Inscription Transcription and Photo(s):

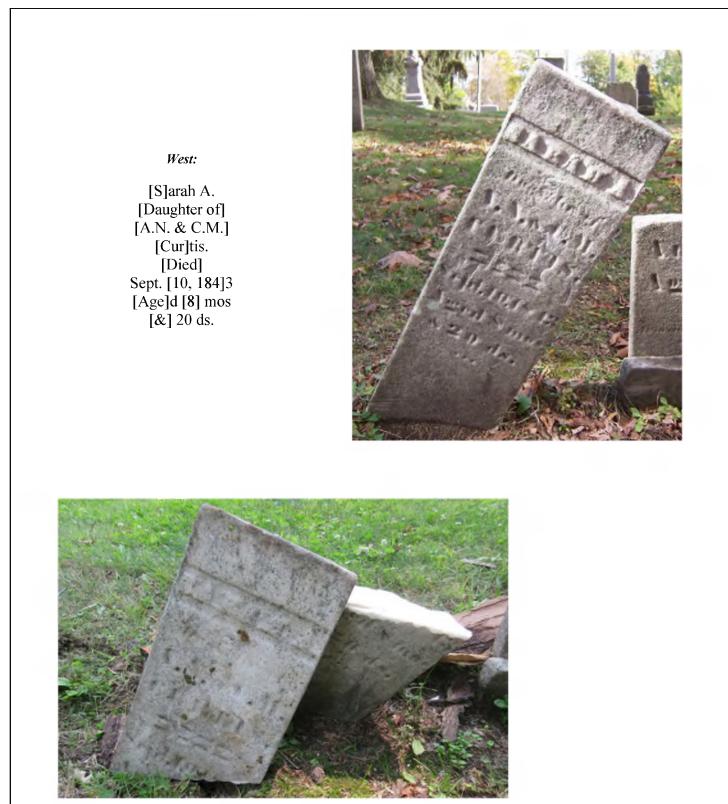
This marker was broken in an early summer 2015 storm by a falling tree branch.

-	commemorated: 1	
# of carved surfa		
Stonecutter mark		
Stoneoutter mur		
Gravestone Design Fea	tures/Motifs: none	
Material:		Gravestone Dimensions:
X Marble	Granite	Height: 26.5"
Limestone	Sandstone	Width: 8.75"
Zinc	Other Stone/Mater	rial Thickness: 2"
	(describe)	
Condition of Marker:		
Sound	Stained / Disc	colored 🗌 Buried
Weathered		$\overline{\mathbf{x}}$ Broken—# of pieces: 2
Vandalized	Unattached to	
$\boxed{\mathbf{x}}$ Leaning in Ground	Repaired	Biological (moss / lichen covered)
Missing (base only)	_	round, but marks grave) Displaced (not marking grave)
$\overline{\mathbf{x}}$ Mower Scars	Portions Miss	
$\overline{\mathbf{x}}$ Other (describe): Some lami		
Type of Marker / Mon	ument.	Type of Tombstone Arch:
	eadstone	rectangular
	-dizut 1	Tootangulai
Previous Repairs:		
Remarks / Comments:
