Inscription Transcription and Photo(s):

Lat / Long: $42^\circ~25'~46.71"~N$, $~83^\circ~29'~10.68"~W$

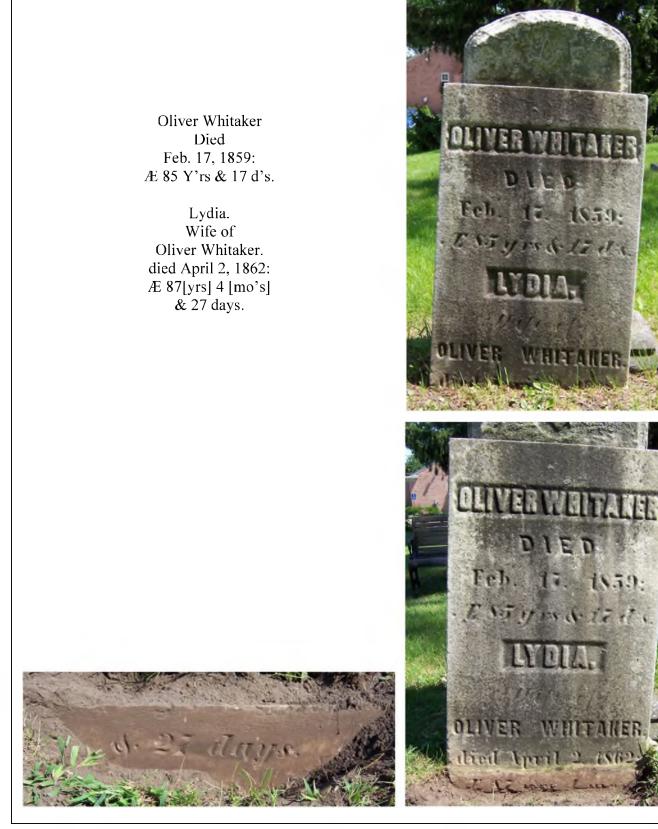
Marble Granite Height: 44.5" (total) Limestone Sandstone Width: 23.75" Zinc Other Stone/Material Thickness: 2" describe) Sound Stained / Discolored Buried Sound Stained / Discolored Buried Weathered Cracked Broken—# of pieces: 2 Vandalized Unattached to Base Overgrown (grass / groundcover) Leaning in Ground Repaired Biological (moss / lichen covered) Missing (base only) Loose (not in ground. but marks grave) Displaced (not marking grave) Mower Scars Portions Missing (list): Displaced (not marking grave) Mower Scars Portions Missing (list): Displaced (not marking grave) Other (describe): Stone is currently leaning against Marker 154. The base is buried in place just north of Marker 154.	Gravestone Design Feat	ures/Motifs: none		
Limestone Sandstone Width: 23.75" Zinc Other Stone/Material Thickness: 2" Condition of Marker: Image: Condition of Marker: Sound Stained / Discolored Buried Weathered Cracked Broken—# of pieces: 2 Vandalized Unattached to Base Overgrown (grass / groundcover) Leaning in Ground Repaired Biological (moss / lichen covered) Missing (base only) Loose (not in ground, but marks grave) Displaced (not marking grave) Mower Scars Portions Missing (list): Stone is currently leaning against Marker 154. The base is buried in place just north of Marker 154. Type of Marker / Monument: Type of Tombstone Arch: rectangular	Material:	Gravestone Dimensions:

Leaning in Ground Repaired Biological (moss / lichen covered) Missing (base only) Loose (not in ground, but marks grave) Mower Scars Portions Missing (list): Other (describe): Stone is currently leaning against Marker 154. The base is buried in place just north of Marker 154. Type of Marker / Monument: headstone 	Weathered	Cracked		oken—# of pieces: 2
 Missing (base only) Loose (not in ground, but marks grave) Displaced (not marking grave) Mower Scars Portions Missing (list): Other (describe): Stone is currently leaning against Marker 154. The base is buried in place just north of Marker 154. Type of Marker / Monument: headstone 	Vandalized	Unattached	to Base 🗌 O	vergrown (grass / groundcover)
 Mower Scars Portions Missing (list): Other (describe): Stone is currently leaning against Marker 154. The base is buried in place just north of Marker 154. Type of Marker / Monument: headstone 	Leaning in Ground	Repaired	🗌 Bi	ological (moss / lichen covered)
