Marker # 201

Marker # 201A

Marker # 201C

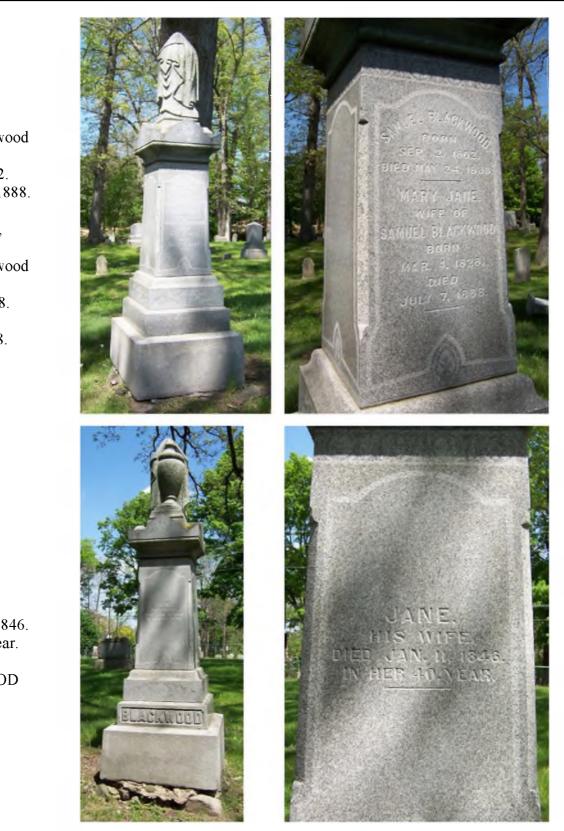
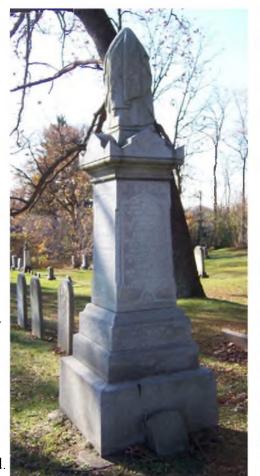
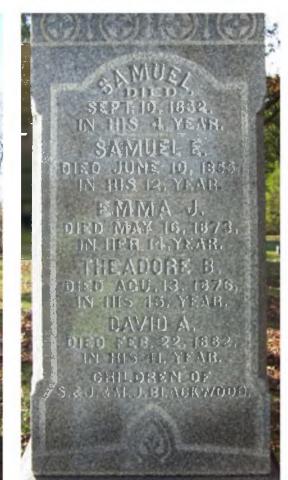
- X Excellent
- Clear but worn
- Mostly decipherable
- Mostly undecipherable

Gravestone Design Features/Motifs: shrouded urn

Material: Gravestone Dimensions: 1: 32"h x 13"w x 12"d (urn) Marble X Granite 2: 14.5"h x 24"w x 24"d Limestone Sandstone 3: 38"h x 20"w x 20"d Zinc Other Stone/Material 4: 10.5"h x 25.75"w x 25.75"d (describe) 5: 8.25"h x 29.25"w x 29.5"d 6: 18"h x 36.75"w x 36.25"d **Condition of Marker:** Total Height: 121.25" Sound Stained / Discolored Buried Cracked Broken—# of pieces: Weathered Vandalized Unattached to Base **Overgrown** (grass / groundcover) Biological (moss / lichen covered) Leaning in Ground **Repaired** Loose (not in ground, but marks grave) Displaced (not marking grave) **Missing** (base only) Portions Missing (list): Mower Scars Other (describe):

Type of Marker / Monument: pedestal tomb - urn

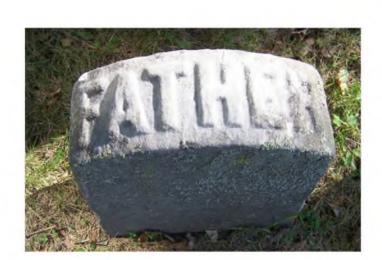
Condition of Inscription:		Inscription Tech	nique:	
X Excellent		Incised		
Clear but worn		\mathbf{x} Relief		
Mostly decipherable		Other (describe):		
Mostly undecipherab	le			
· · · ·				
Inscription:				
# of individuals com				
# of carved surfaces:	1			
Stonecutter mark: no				
Gravestone Design Feature	es/Motifs: none			
Material:	Gravestone Dimensions:			
X Marble	Granite	Hei	ght: 10.5"	
Limestone	Sandstone	Wic	lth: 10"	
Zinc [Other Stone/Mate (describe)	rial Thio	ckness: 4"	
Condition of Marker:				
Sound	Stained / Dis	colored	Buried	
Weathered	Cracked		Broken—# of pieces:	
Uandalized	Unattached to	o Base	Overgrown (grass / groundcover)	
Leaning in Ground	Repaired		Image: Second state Biological (moss / lichen covered)	
Missing (base only)	Loose (not in g	round, but marks grave)	Displaced (not marking grave)	
Mower Scars	Portions Mis	sing (list):		
Other (describe):

"die in socket"- style footstone

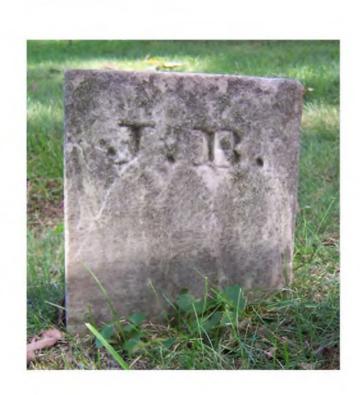
Condition of Inscription:	J	Inscription Tec	hnique:
Excellent		Incised	
\mathbf{x} Clear but worn		🗌 Relief	
Mostly decipherable		Other (des	scribe):
Mostly undecipherable	2		
Inscription:			
# of individuals comm	emorated: 1		
# of carved surfaces: 1			
Stonecutter mark: no			
Stonecutter mark. no			
Gravestone Design Features	/Motifs: none		
Material:		Gravestor	ne Dimensions:
X Marble	Granite	H	eight: 10"
Limestone	Sandstone	W	/idth: 9"
Zinc	Other Stone/Mater (describe)	ial Tl	hickness: 1.5"
Condition of Marker:			
Sound	Stained / Disc	olored	Buried
Weathered	Cracked		Broken—# of pieces:
Uandalized	Unattached to	Base	Overgrown (grass / groundcover)
Leaning in Ground	Repaired		Biological (moss / lichen covered)
Missing (base only)	Loose (not in gro	ound, but marks grav	e) Displaced (not marking grave)
$\overline{\mathbf{X}}$ Mower Scars	Portions Miss	ing (list):	
Other (describe):

headstone-style footstone

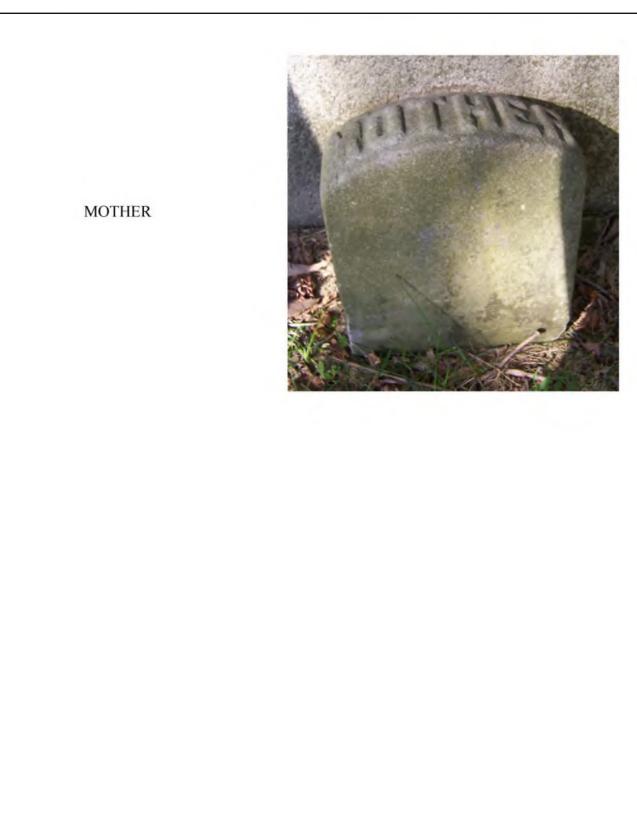
Condition of Inscription:]	Inscription To	echnique:
X Excellent		Incised	
Clear but worn		X Relief	
Mostly decipherable		Other (d	lescribe):
Mostly undecipherable			
Inscription:			
# of individuals comme	emorated: 1		
# of carved surfaces: 1			
Stonecutter mark: no			
Gravestone Design Features/	Motifs: none		
Material:		Gravest	one Dimensions:
Marble	Granite		Height: 12"
Limestone	Sandstone		Width: 10"
Zinc	Other Stone/Mater (describe)	ial	Thickness: 4"
Condition of Marker:			
Sound	Stained / Disc	olored	Buried
Weathered	Cracked		Broken—# of pieces:
Uandalized	Unattached to	Base	Overgrown (grass / groundcover)
Leaning in Ground	Repaired		Biological (moss / lichen covered)
Missing (base only)	Loose (not in gro	ound, but marks gr	ave) لکا Displaced (not marking grave)
Mower Scars	Portions Miss	ing (list):	
Other (describe):

"die in socket"- style footstone

Previous Repairs: The buried socket has cement on it, but the marker is no longer attached to it.

Remarks / **Comments:** See also Marker 201 (Mary Jane Blackwood). This marker is currently leaning on the Blackwood monument (Marker 201). The socket for this marker was found buried 3 feet north of the "Father" footstone (Marker 201A).
