Inscription Transcription and Photo(s):

Marker # 315 Surname(s): Hamblin

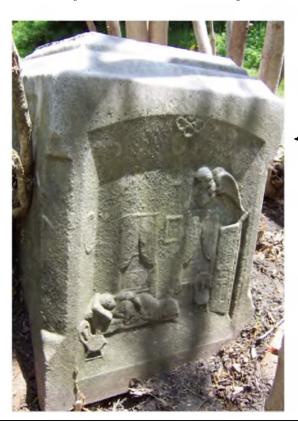
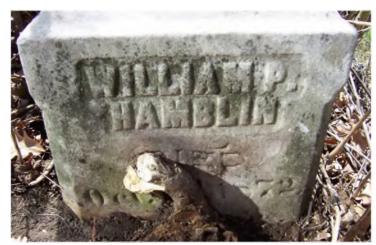
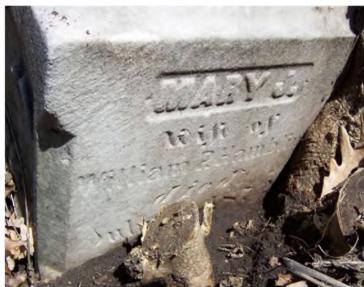
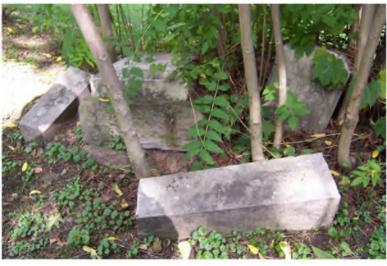
Condition of Inscription	ı: I	nscription Technique:
X Excellent		\(\sqrt{\text{Incised}} \)
Clear but worn		X Relief
Mostly decipheral	ole	Other (describe):
Mostly undeciphe	rable	
Tona Zadža sa		
Inscription: # of individuals co

# of carved surfac Stonecutter mark:	**	
Stonecutter mark.	ulikilowii	
Gravestone Design Feat	ures/Motifs: bedroom s	cene with angel looking down on someone sleeping
Material:		Gravestone Dimensions:
\overline{X} Marble $(1, 2, 3)$	☐ Granite	1: 60"h x 10.25"w x 10.5"d (assembled)
Limestone	X Sandstone (4)	2: 21.5"h x 16.25"w x 17"d
Zinc Zinc	Other Stone/Material (describe)	al 3: 6.25"h x 22.5"w x 22.5"d

4: 10.25"h x 27.5"w x 28"d
		Total Height: 98" (assembled)
Condition of Marker:		
Sound	Stained / Disco	olored Buried
☐ Weathered	Cracked	Broken—# of pieces: 4 (see note)
☐ Vandalized	Unattached to	Base
Leaning in Ground	Repaired	Biological (moss / lichen covered)
Missing (base only)	Loose (not in ground, but marks grave) Lisplaced (not marking grave)	
Mower Scars	Portions Missi	ng (list):
	rt of this marker that is actually as just need to be stacked on to	broken is the obelisk (Section 1), which is in two pieces. The p of each other again.
Type of Marker / Monu	ment: obelisk	
Previous Repairs:

Remarks / Comments: This marker has been toppled by a multiple-trunked Tree of Heaven (*Ailanthus altissima*). According to Wikipedia, "It is considered a noxious weed in the United States . . . [and] resprouts vigorously when cut, making its eradication difficult and time consuming." This tree would have to be exterminated before this marker could be re-set in the proper location.
