Inscription Transcription and Photo(s):

Marker # 327A

Marker # 327B

Marker # 327C

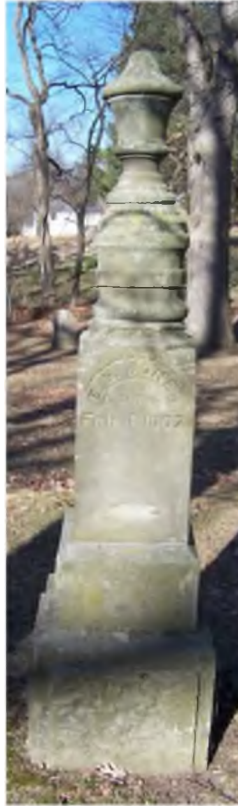
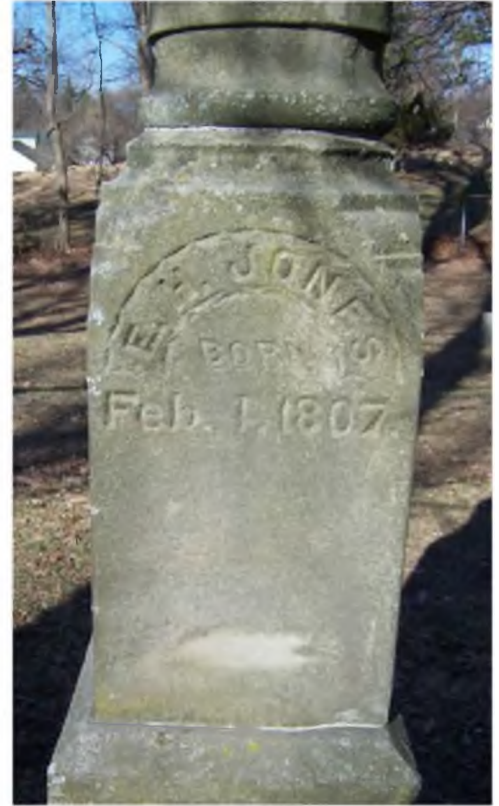
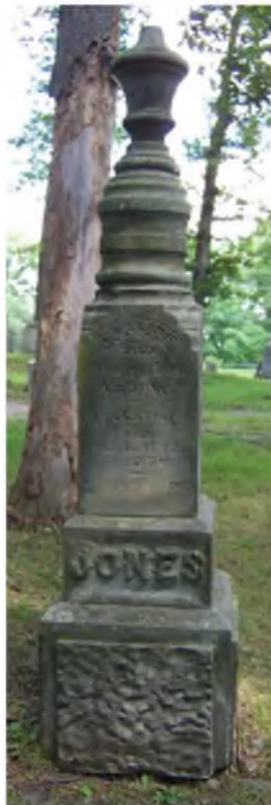
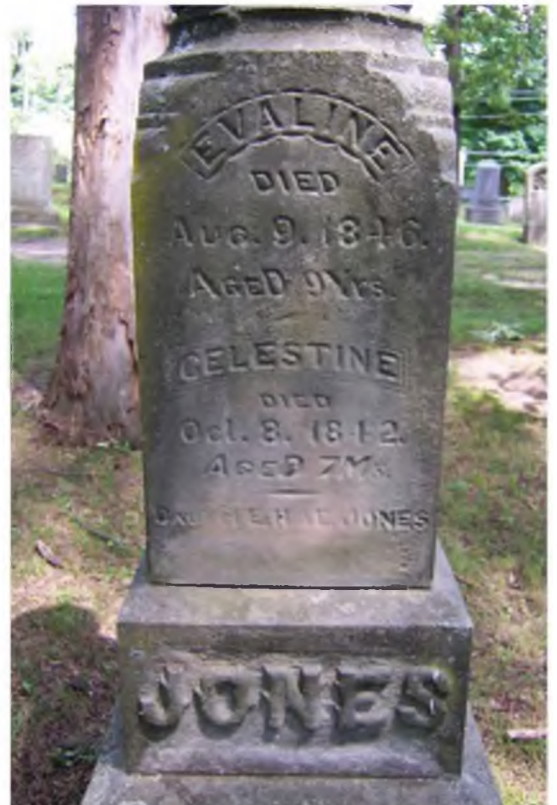
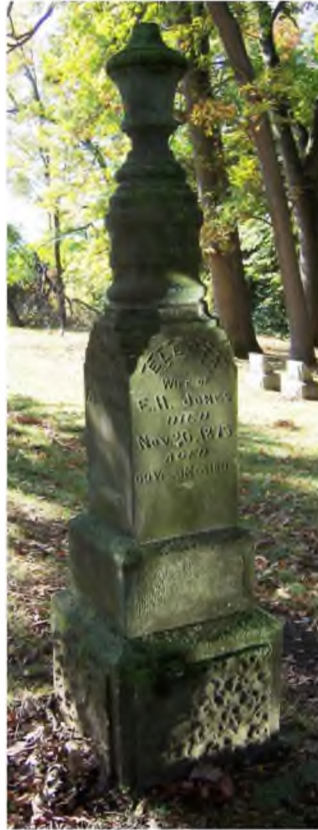
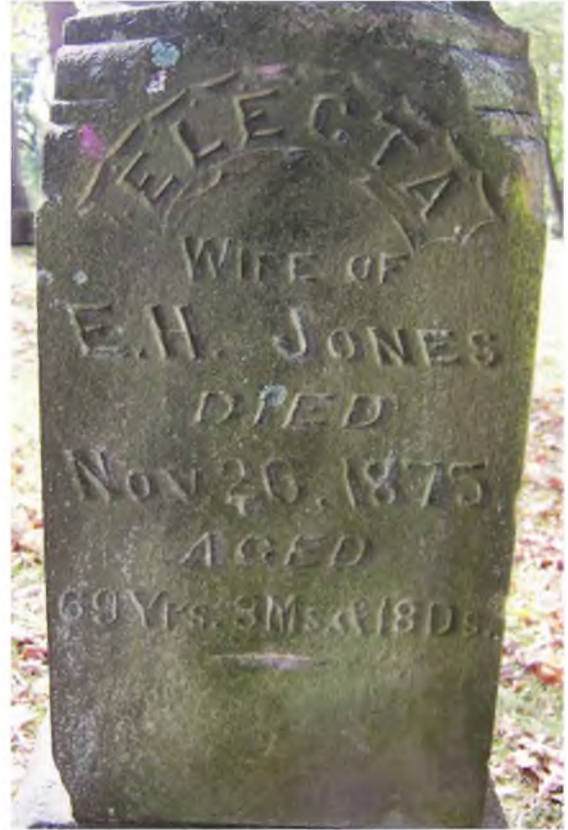
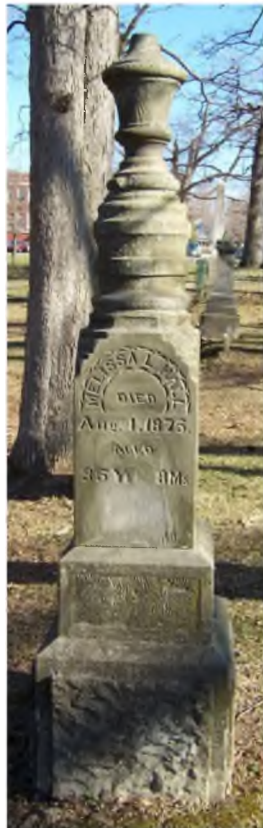
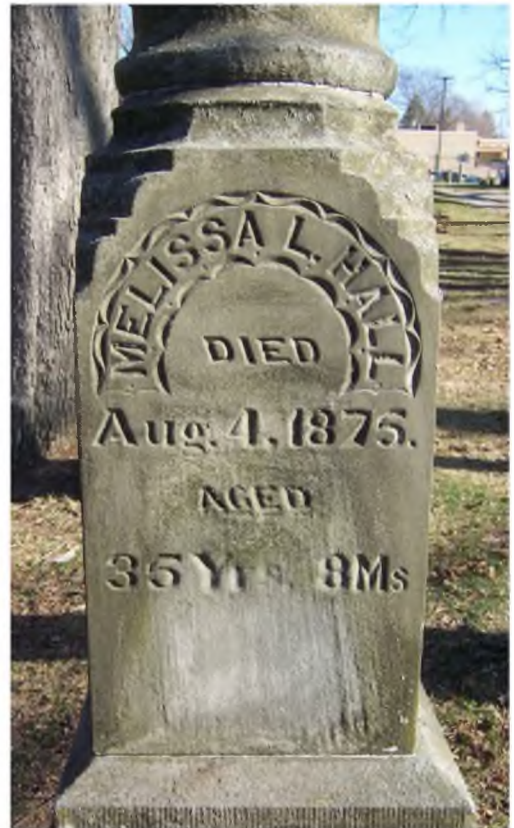
- 1: 18" h x 9" diameter
- 2: 14" h x 12" diameter
- 3: 27.25" h x 14.25" w x 14" d
- 4: 10.5" h x 17.5" w x 17.75" d
- 5: 19.75" h x 22.5" w x 22.5" d
- Total Height: 89.5"

| <input type="checkbox"/> Mower Scars | <input checked="" type="checkbox"/> Portions Missing (list): | There is a hole at the very top. Some sort of finial is missing from the top of this monument. |
| <input checked="" type="checkbox"/> Other (describe): | Section 3 is shifted on Section 4. | |

pedestal tomb—urn

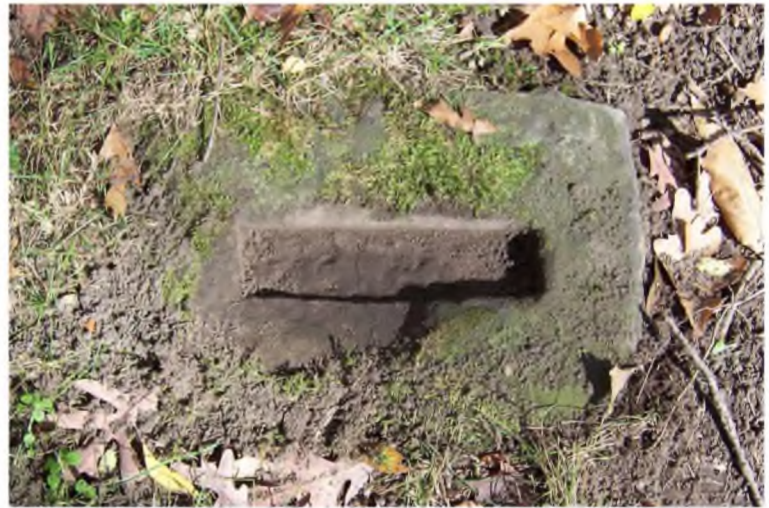
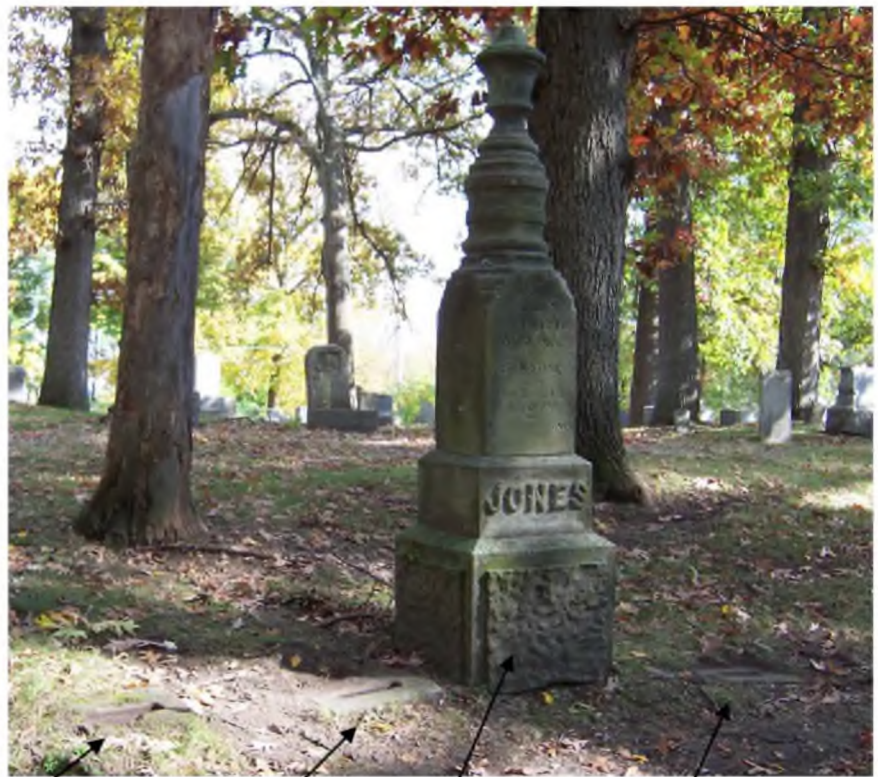
This socket would have held a marker 9.25" wide and 2.25" deep.

| <input type="checkbox"/> Vandalized | <input type="checkbox"/> Unattached to Base | <input checked="" type="checkbox"/> Overgrown (grass / groundcover) |
| <input type="checkbox"/> Leaning in Ground | <input type="checkbox"/> Repaired | <input checked="" type="checkbox"/> Biological (moss / lichen covered) |
| <input checked="" type="checkbox"/> Missing (base only) | <input type="checkbox"/> Loose (not in ground, but marks grave) | <input type="checkbox"/> Displaced (not marking grave) |

socket only

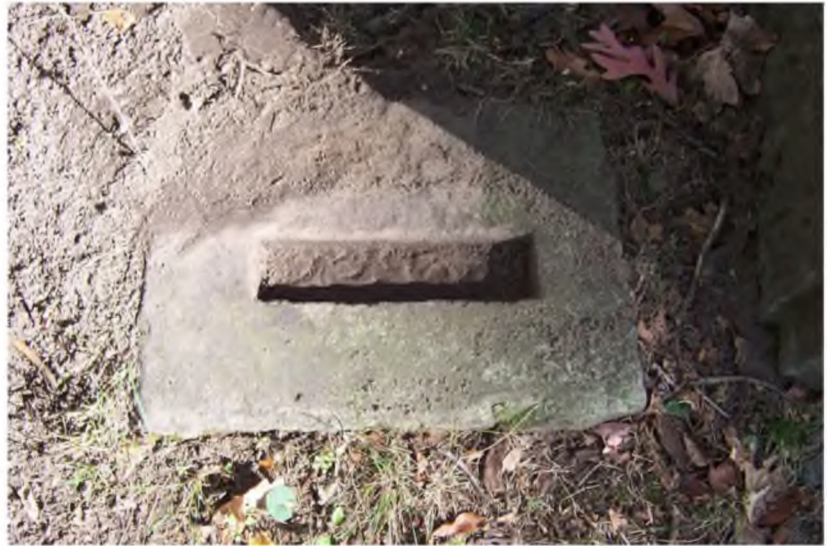
This socket would have held a marker 9" wide and 2.25" deep.

| <input checked="" type="checkbox"/> Missing (base only) | <input type="checkbox"/> Loose (not in ground, but marks grave) | <input type="checkbox"/> Displaced (not marking grave) |

socket only

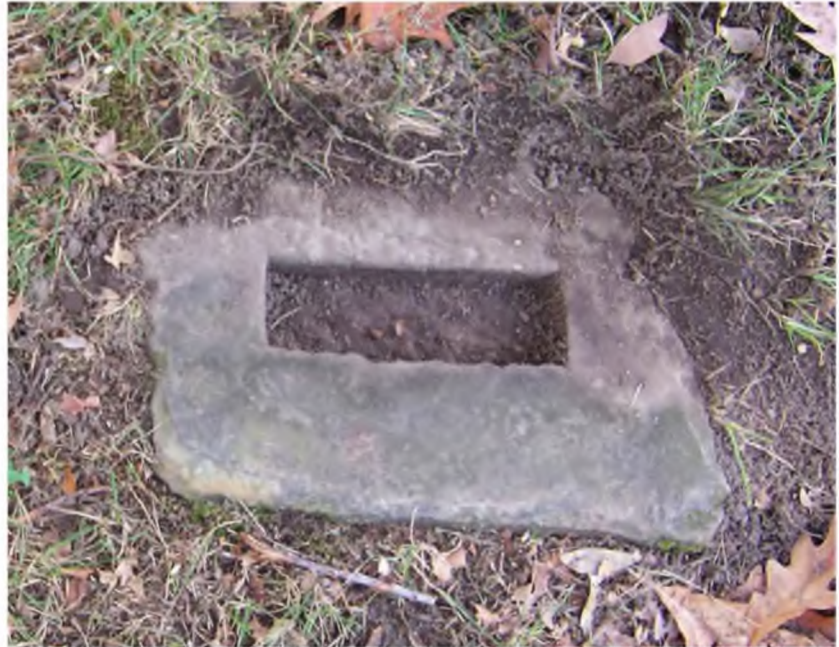
This socket would have held a marker
7.25" wide and 2.5" deep.

| <input type="checkbox"/> Vandalized | <input type="checkbox"/> Unattached to Base | <input checked="" type="checkbox"/> Overgrown (grass / groundcover) |
| <input checked="" type="checkbox"/> Missing (base only) | <input type="checkbox"/> Loose (not in ground, but marks grave) | <input type="checkbox"/> Displaced (not marking grave) |

socket only

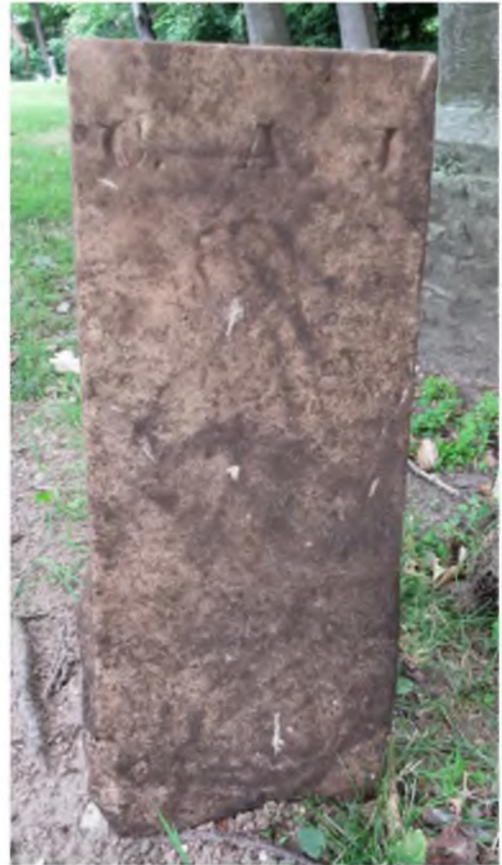
Marker # 327D

| <input type="checkbox"/> Sound | <input type="checkbox"/> Stained / Discolored | <input checked="" type="checkbox"/> Buried |

headstone-style footstone

Remarks / Comments: This footstone is buried on the north side of Marker 327. It could be a footstone for Celestine Jones (see Marker 327).
