Inscription Transcription and Photo(s):

Marker # 338 Surname(s): Burlingame

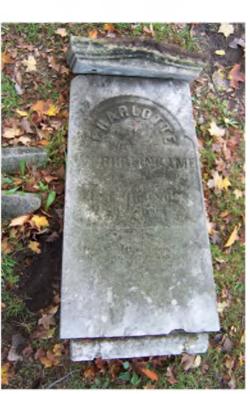
original placement of cap piece

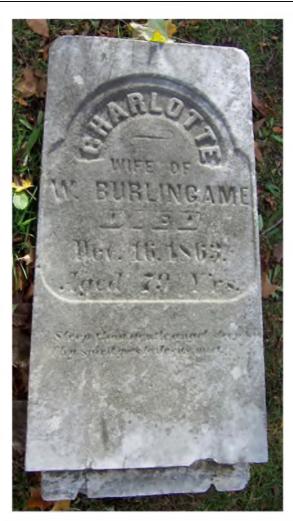
Charlotte
Wife of
W. Burlingame
Died
Dec. 16, 1863.
Aged 79 Y'rs.

Sleep thou gentle angel sleep Thy spirit goes to Jesus meet.

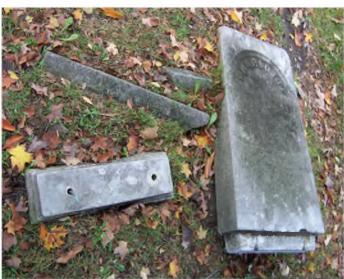
current arrangement of pieces

Previous Repairs: This marker was originally held in the socket with pins. At some point, the pins failed and cement was used to hold the marker in the socket. The socket is now broken into multiple pieces.
