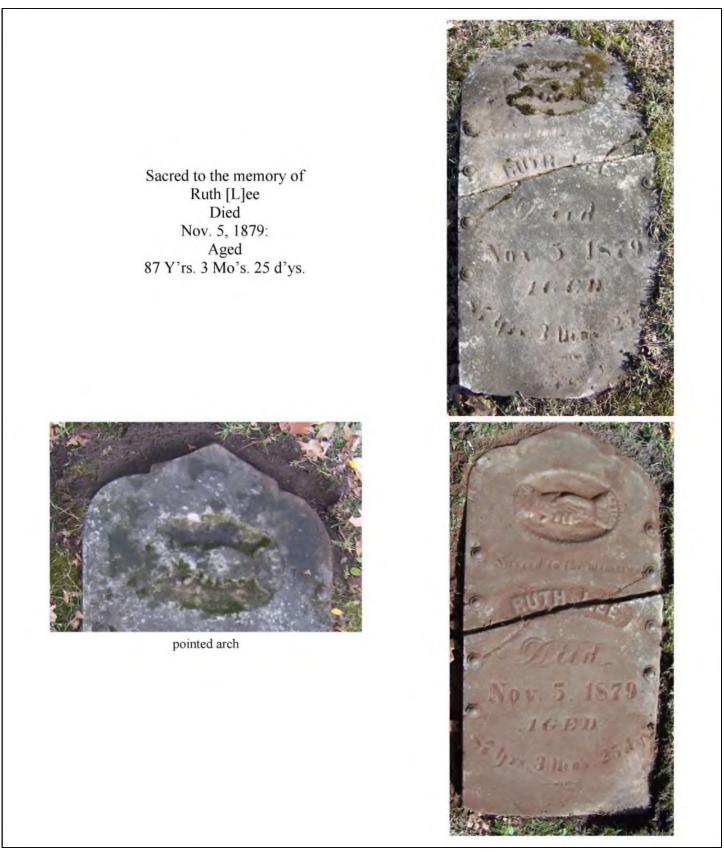
| Condition of Inscription:<br>Excellent<br>Clear but worn<br>Mostly decipherable<br>Mostly undecipherable<br>Inscription:<br># of individuals comme<br># of carved surfaces: 1<br>Stonecutter mark: no | | 1 |
|---|--|--|
| <ul> <li>Sound</li> <li>Weathered</li> <li>Vandalized</li> <li>Leaning in Ground</li> <li>Missing (base only)</li> <li>Mower Scars</li> <li>Other (describe): The marker is brocents</li> </ul> | <ul> <li>Stained / Discolored</li> <li>Cracked</li> <li>Unattached to Base</li> <li>Repaired</li> <li>Loose (not in ground, but marks</li> <li>Portions Missing (list):</li> <li>ken across the bottom. The base is but</li> </ul> | Buried<br>Broken—# of pieces: 3<br>Overgrown (grass / groundcover)<br>Biological (moss / lichen covered)<br>grave) Displaced (not marking grave)<br>ried under the bottom left corner of the marker. |

**Previous Repairs:** Steel bands have been bolted onto the back of this marker along both edges. Cracks are now forming at most of these bolt holes. The base has cement on it, so it was also cemented in place at some point.
