# **Inscription Transcription and Photo(s):**

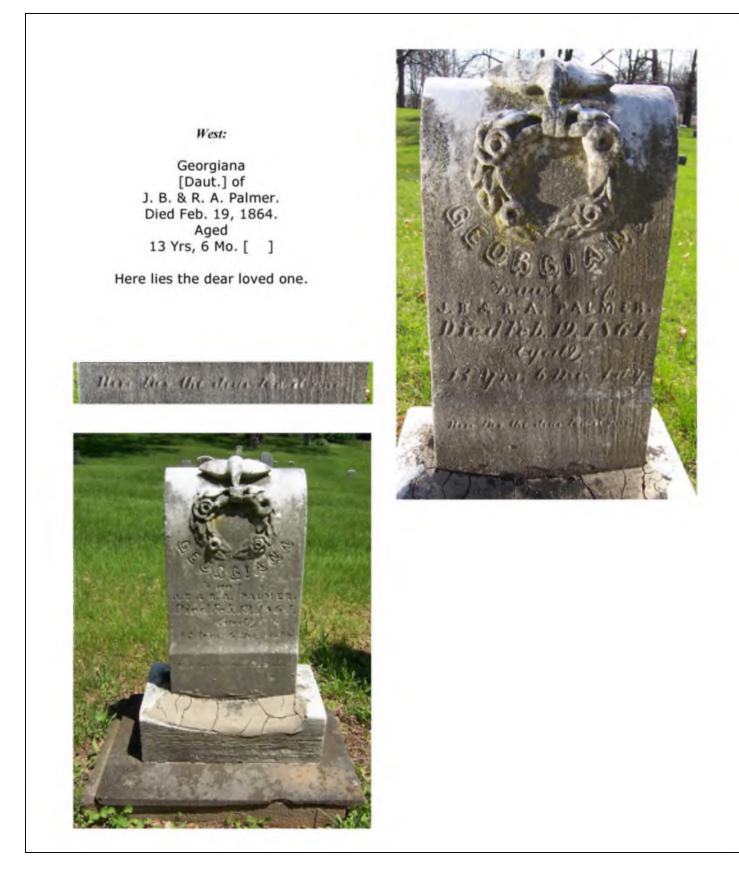
<b>Condition of Inscription:</b>	Inscription Technique:
Excellent	X Incised
Clear but worn	🔲 Relief
$\boxed{\mathbf{x}}$ Mostly decipherable	Other (describe):
Mostly undecipherable

## Gravestone Design Features/Motifs: bird (with broken head) holding a floral wreath

Sound	Stained / Discolored	Buried
X Weathered	Cracked	Broken—# of pieces:
Uandalized	Unattached to Base	Overgrown (grass / groundcover)
Leaning in Ground	x Repaired	<b>Biological</b> (moss / lichen covered)
Missing (base only)	Loose (not in ground, but marks grave)	Displaced (not marking grave)
Mower Scars	Portions Missing (list):	
X Other (describe): The sandstone base	e (section 3) has split horizontally and shifte	d.

Previous Repairs: The marble base (section 2) has some cement repair.
