## Inscription Transcription and Photo(s):

Marker # 382 Surname(s): Curtis

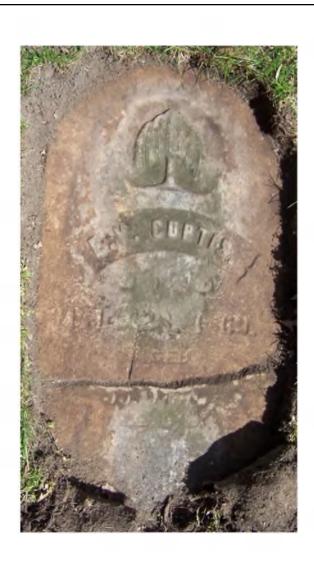
E. V. Curti[s]
[Died]
[Feb. 28, 1869]
[Aged]
[55 Yrs.]

Condition of Inscription:	Inscription Technique:	
Excellent	<u>x</u> Incised	
Clear but worn	X Relief	
Mostly decipherable	Other (describe):	
X Mostly undecipherable		
Inscription:

# of individuals comme	emorated: 1	
# of carved surfaces: 1		
Stonecutter mark: nothi	ng visible	
Gravestone Design Features/Motifs: weeping willow		
Material:	Gravestone l	Dimensions:
Marble      □	Granite Heig	ht: 46" (as is)
Limestone	Sandstone Widt	th: 20"
Zinc	Other Stone/Material Thick (describe)	kness: 2"
Condition of Marker:		
Sound	x Stained / Discolored	Buried
Weathered	☐ Cracked	Broken—# of pieces: 2 found
☐ Vandalized	Unattached to Base	Overgrown (grass / groundcover)
Leaning in Ground	Repaired	Biological (moss / lichen covered)
Missing (base only)	2 Loose (not in ground, but marks grave)	Displaced (not marking grave)
Mower Scars	Portions Missing (list): The lower portion of this stone is missing—probably at	
Other (describe):	least two p	ieces.
<b>Type of Marker / Monument</b> probably headst  no obvious base was fo	one;	tone Arch: semicircular
Previous Repairs: This marker	was repaired with adhesive at some point, but	it has since failed. The stone is now

**Previous Repairs:** This marker was repaired with adhesive at some point, but it has since failed. The stone is now disintegrating in the midsection, on either side of the break.
