Marker # 18

Surname(s): Wheeler, Starkweather, Roberts

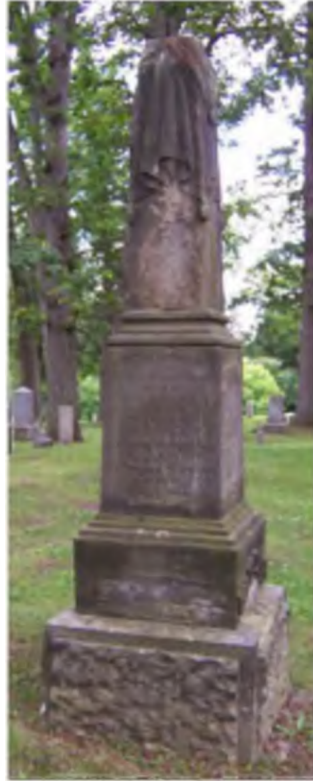
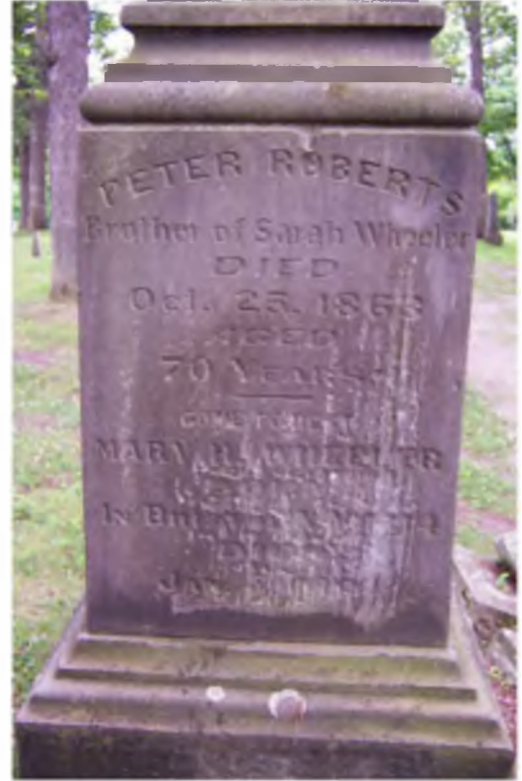
North:

Peter Roberts
Brother of Sarah Wheeler
Died
Oct. 25, 1863
Aged
70 Years.

Come to Rest
Mary H. Wheeler
Born
In Bristol, N.Y., 1814
Died
Jan. [5, 1887]

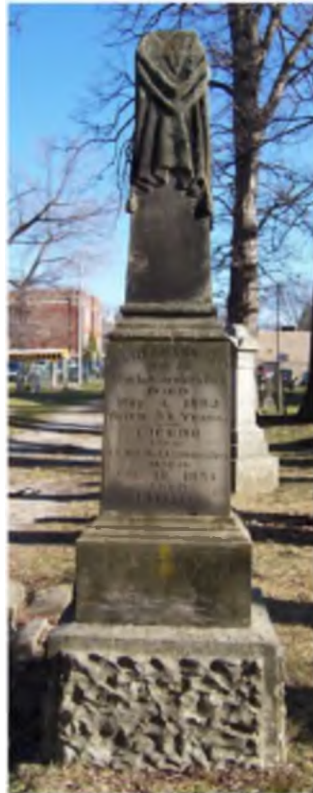
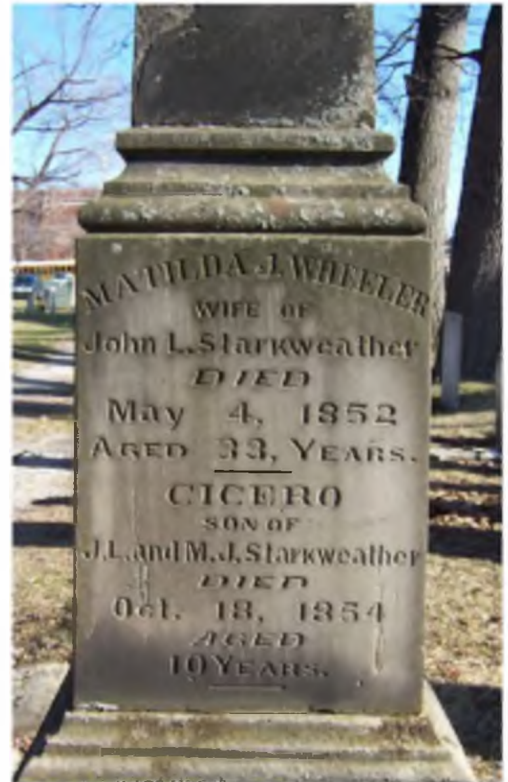
South:

Matilda J. Wheeler
Wife of John L. Starkweather
Died
May 4, 1852
Aged 33, Years.

Cicero
Son of
J.L. and M.J. Starkweather
Died
Oct. 18, 1854
Aged
10 Years.

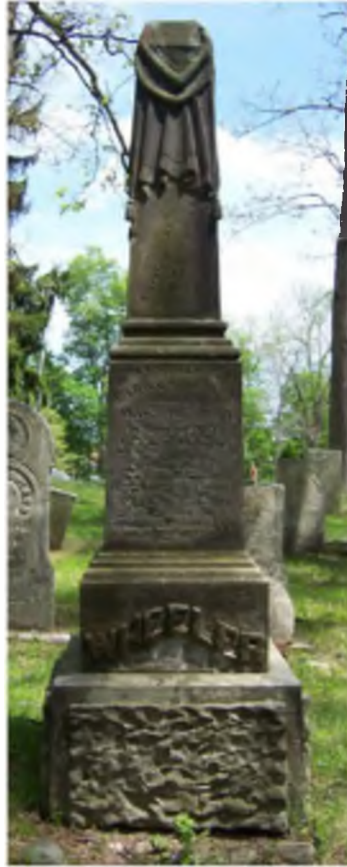
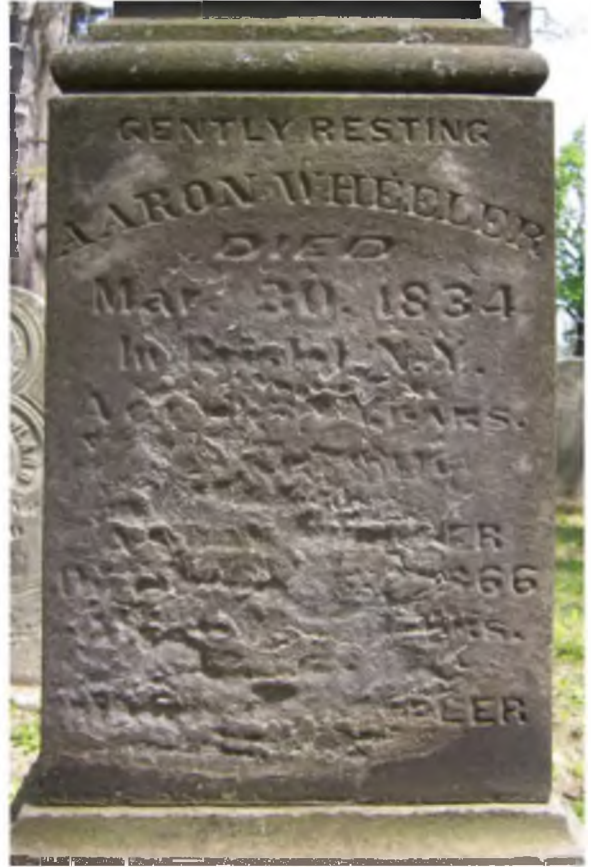
West:

Gently Resting
Aaron Wheeler
Died
Mar. 20, 1834
In [Bristol,] N.Y.
Age[d] [59 Y]ears.

[His Wife]
[Sarah Wheel]er
[Died Oct 31, 18]66
[Aged 85 Year]s.
[Parent of]
[Mary H. Whee]ler

WHEELER

shrouded obelisk

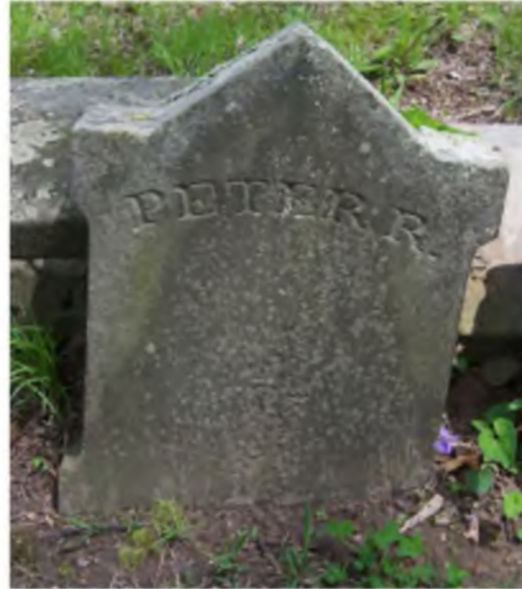
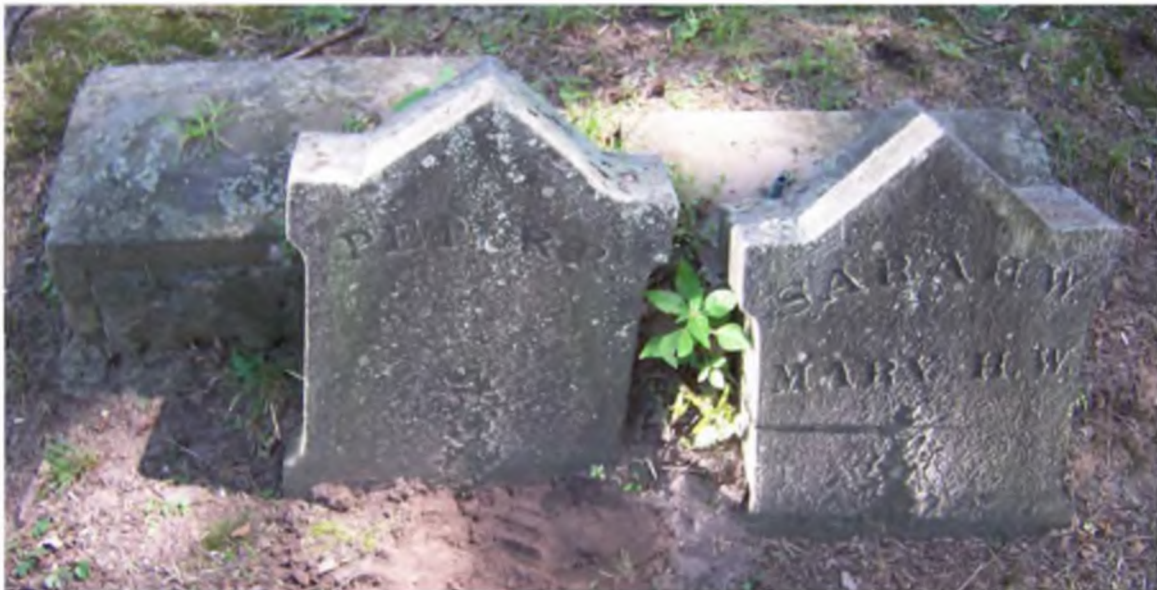
Marker # 18A

Peter R.

1: 19”h x 14”w x 5”d
 2: 9”h x 19.5”w x 11”d
 Total Height: 28”

| <input checked="" type="checkbox"/> Other (describe): The stone is currently leaning on its base. The base is cemented in place. | | |

“die on base”-style footstone

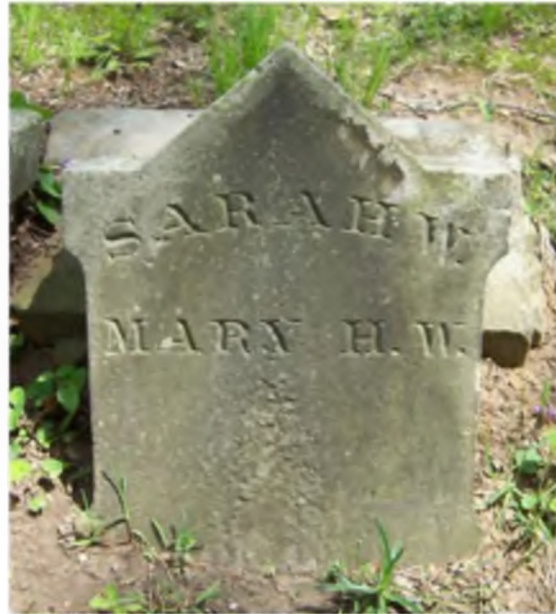
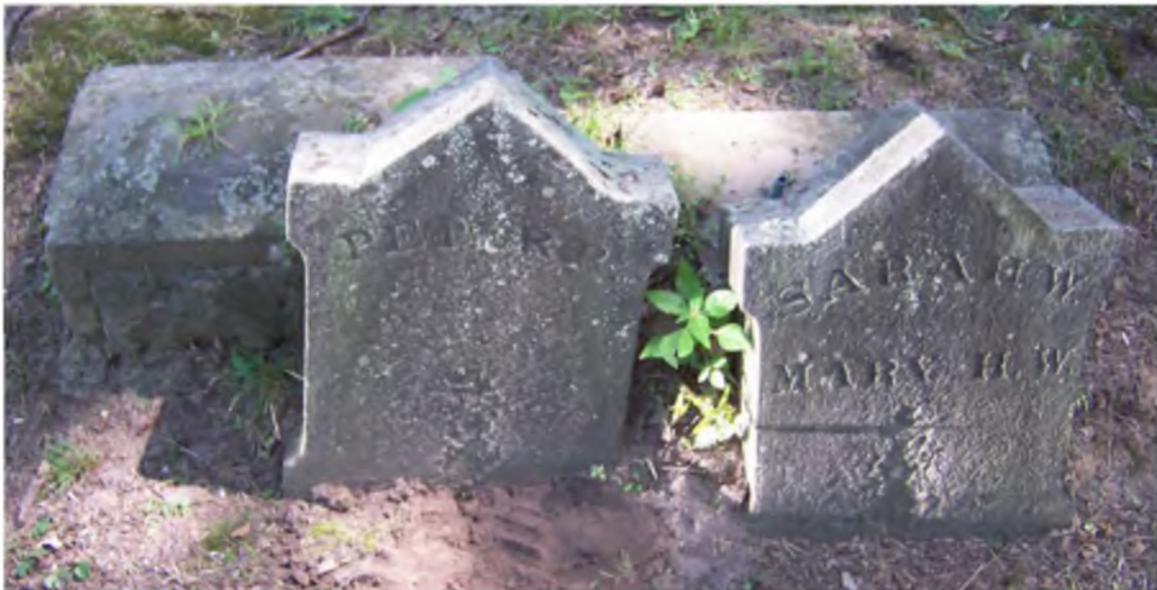
Marker # 18B

Sarah W.
Mary H. W.

1: 19”h x 14”w x 5”d
 2: 9”h x 19.5”w x 11”d
 Total Height: 28”

- Sound
- Weathered
- Vandalized
- Leaning in Ground
- Missing (base only)
- Mower Scars
- Other (describe): The stone is currently leaning on its base, and the base is leaning in the ground.
- Stained / Discolored
- Cracked
- Unattached to Base
- Repaired
- LOOSE (not in ground, but marks grave)
- Portions Missing (list):
- Buried
- Broken—# of pieces:
- Overgrown (grass / groundcover)
- Biological (moss / lichen covered)
- Displaced (not marking grave)

“die on base”-style footstone

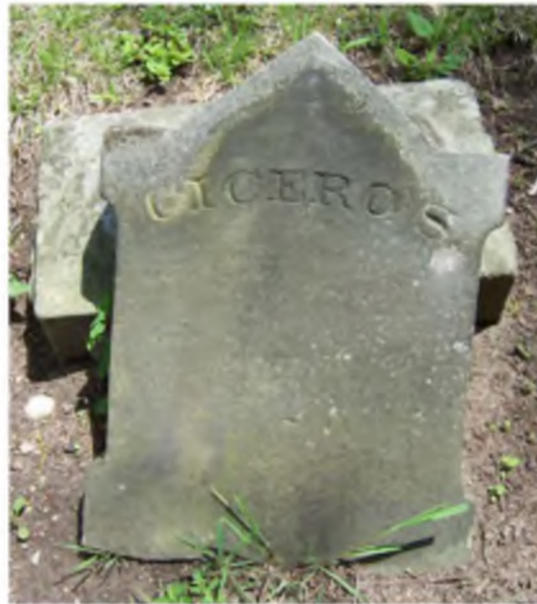
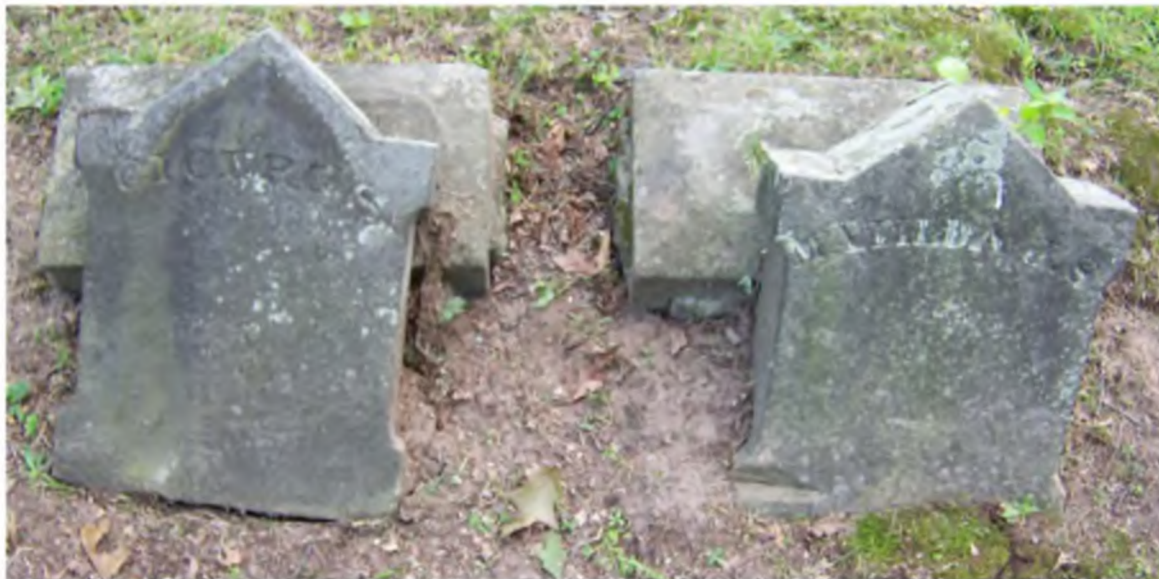
Marker # 18C

Cicero S.

1: 19”h x 14.25”w x 3.25”d
 2: 6”h x 19.25”w x 10”d
 Total Height: 25”

| <input checked="" type="checkbox"/> Other (describe): The stone is currently leaning on its base, and the base is leaning in the ground. | | |

“die on base”-style footstone

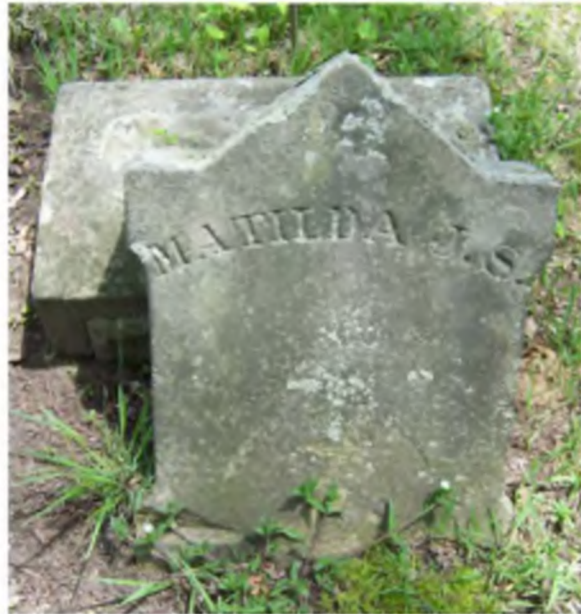
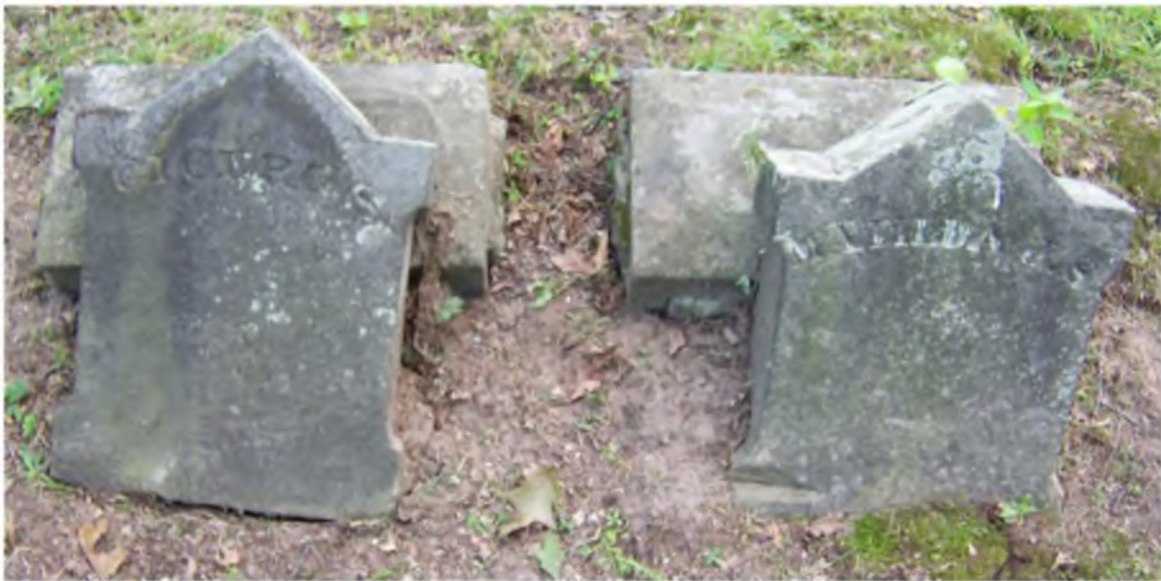
Marker # 18D

Matilda J. S.

1: 19”h x 14”w x 5”d

2: 5”h x 19”w x 11”d

- Sound
- Weathered
- Vandalized
- Leaning in Ground
- Missing (base only)
- Mower Scars
- Other (describe): The stone is currently leaning on its base, and the base is leaning in the ground.
- Stained / Discolored
- Cracked
- Unattached to Base
- Repaired
- LOOSE (not in ground, but marks grave)
- Portions Missing (list):
- Buried
- Broken—# of pieces:
- Overgrown (grass / groundcover)
- Biological (moss / lichen covered)
- Displaced (not marking grave)

“die on base”-style footstone
