Marker # 185

Surname(s): Brooks

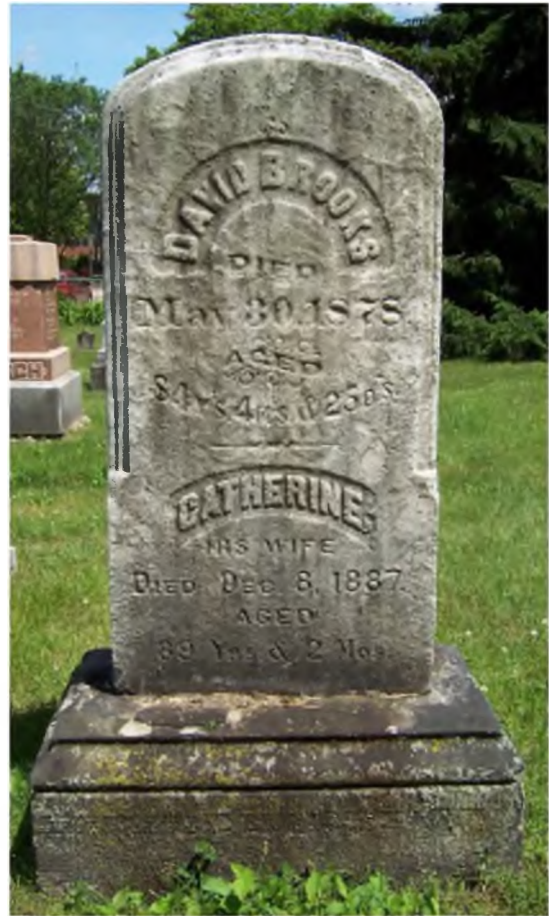
1: 40”h x 20”w x 6”d  
 2: 12.5”h x 29.75”w x 15.5”d  
 Total Height: 52.5”

- Sound
- Weathered
- Vandalized
- Leaning in Ground
- Missing (base only)
- Mower Scars
- Other (describe):
- Stained / Discolored
- Cracked
- Unattached to Base
- Repaired
- Loose (not in ground, but marks grave)
- Portions Missing (list):
- Buried
- Broken—# of pieces:
- Overgrown (grass / groundcover)
- Biological (moss / lichen covered)
- Displaced (not marking grave)

die in socket

**Previous Repairs:** This marker has been cemented into its socket, but the socket is now starting to fail.

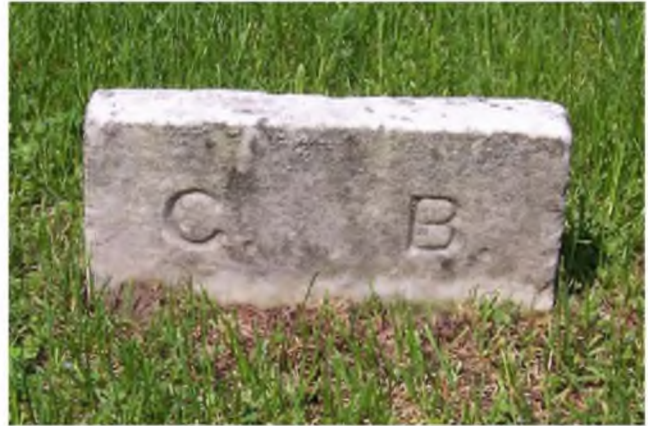
Marker # 185A

Height: 4.5"  
 Width: 10.25"  
 Thickness: 1.75"

- Sound
- Weathered
- Vandalized
- Leaning in Ground
- Missing (base only)
- Mower Scars
- Other (describe): This marker is broken across the bottom, but is still in place.
- Stained / Discolored
- Cracked
- Unattached to Base
- Repaired
- Loose (not in ground, but marks grave)
- Portions Missing (list):
- Buried
- Broken—# of pieces: 1 found
- Overgrown (grass / groundcover)
- Biological (moss / lichen covered)
- Displaced (not marking grave)

footstone
