Marker # 198

Surname(s): Bovee, Swits

Susan Swits
Wife of
M. J. Bovee
[Died]
Dec. 28, 1874.
Aged
50 Years

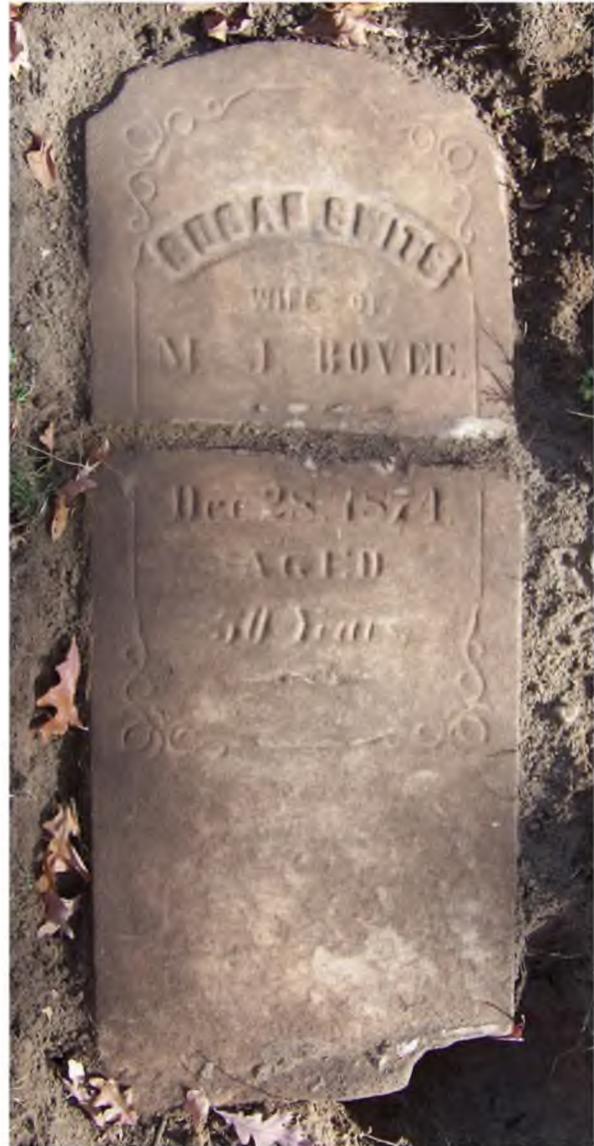
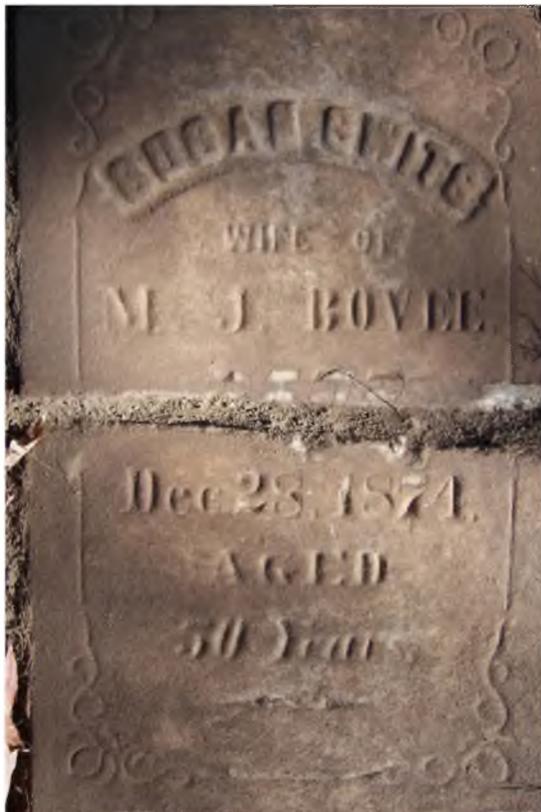
Broken yellow clay
flowerpot found buried
beneath bottom of stone
(and reburied)

- Sound
- Weathered
- Vandalized
- Leaning in Ground
- Missing (base only)
- Mower Scars
- Other (describe):
- Stained / Discolored
- Cracked
- Unattached to Base
- Repaired
- Loose (not in ground, but marks grave)
- Portions Missing (list):
- Buried
- Broken—# of pieces: 3
- Overgrown (grass / groundcover)
- Biological (moss / lichen covered)
- Displaced (not marking grave)

Previous Repairs: The broken pieces were once caulked together, but have since come apart again. A small amount of cement near the base of the marker shows it was once cemented into its socket.

Remarks / Comments: The bottom of this marker is unfinished, not broken. The socket for this marker should be the same as the one for Marker 197, but it has not been found. A cobble foundation for the base was found buried under the bottom of the marker, but the socket is not buried there. The bottom right corner of the marker is broken off and was found buried under the stone.
