Marker # 238

Surname(s): Clarkson

pedestal tomb - vaulted roof

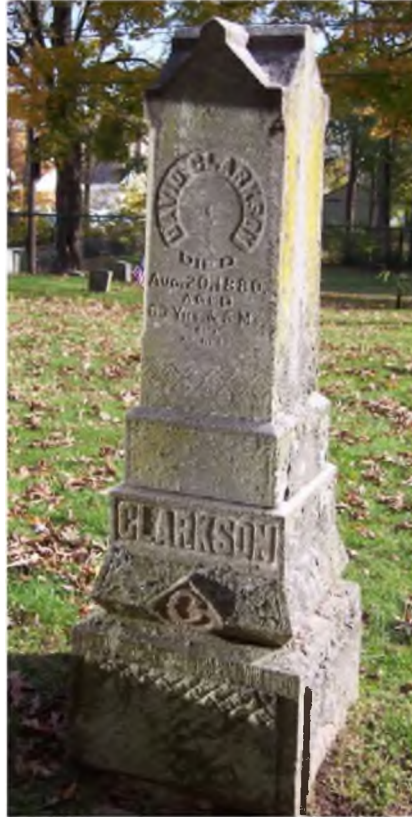
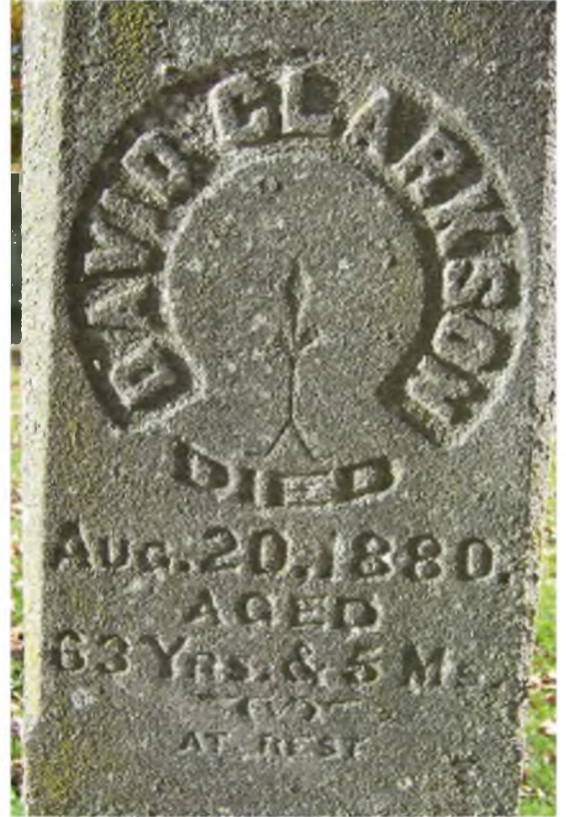
West:

David Clarkson
Died
Aug. 20, 1880.
Aged
63 Yrs. & 5 Ms.
At Rest.

- Sound
- Weathered
- Vandalized
- Leaning in Ground
- Missing (base only)
- Mower Scars
- Other (describe): Section 2 is shifted on Section 3.
- Stained / Discolored
- Cracked (Section 1)
- Unattached to Base
- Repaired
- Loose (not in ground, but marks grave)
- Portions Missing (list):
- Buried
- Broken—# of pieces:
- Overgrown (grass / groundcover)
- Biological (moss / lichen covered)
- Displaced (not marking grave)

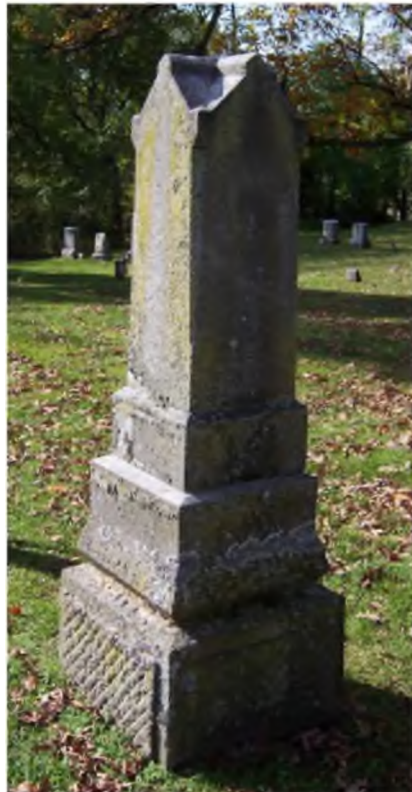
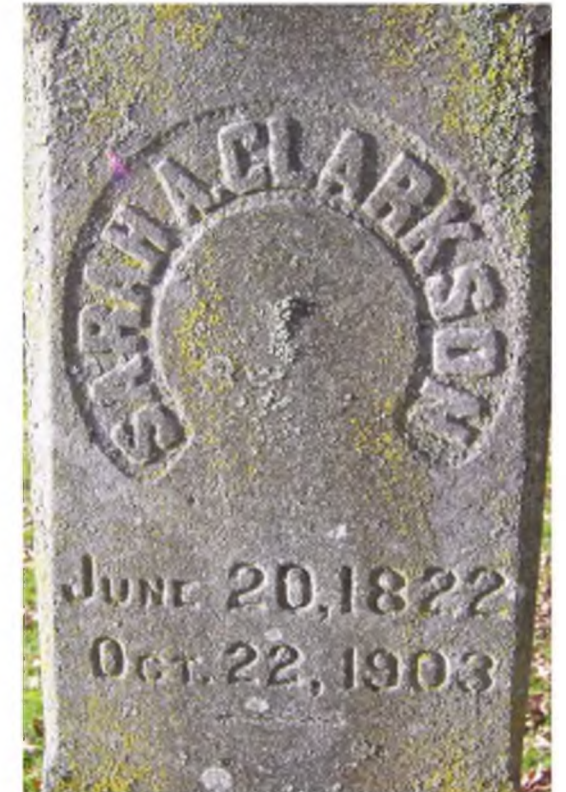
North:

Sarah A. Clarkson
June 20, 1822
Oct. 22, 1903

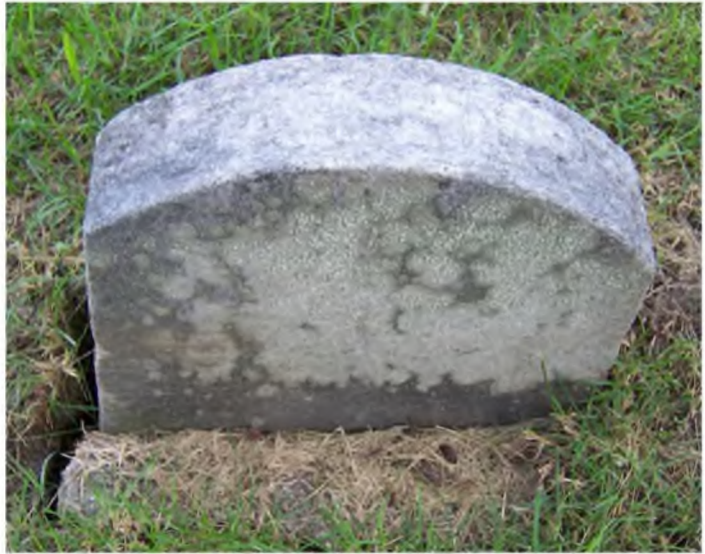
Oriented West:

FATHER

Previous Repairs: This marker has been cemented in place, but the cement is now broken and the marker is leaning.

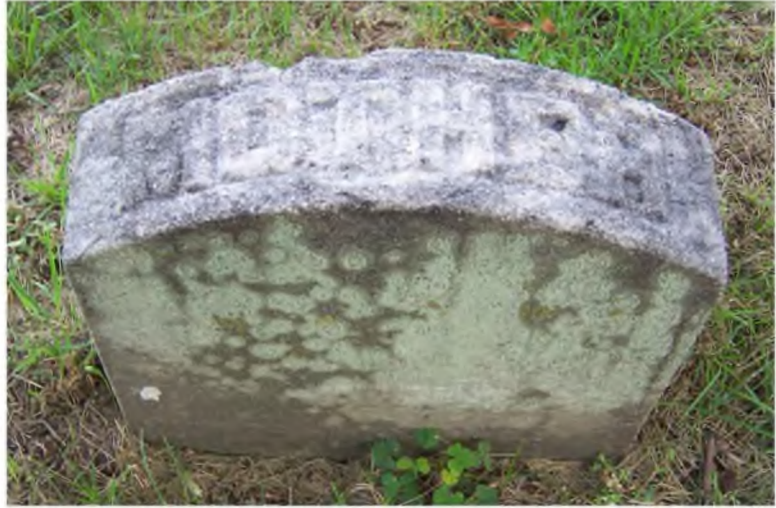
Oriented West:

MOTHER

| <input type="checkbox"/> Leaning in Ground | <input checked="" type="checkbox"/> Repaired | <input checked="" type="checkbox"/> Biological (moss / lichen covered) |

Previous Repairs: This marker has been cemented in place.
