Marker # 243

Surname(s): Cummins

Inscription Transcription and Photo(s):

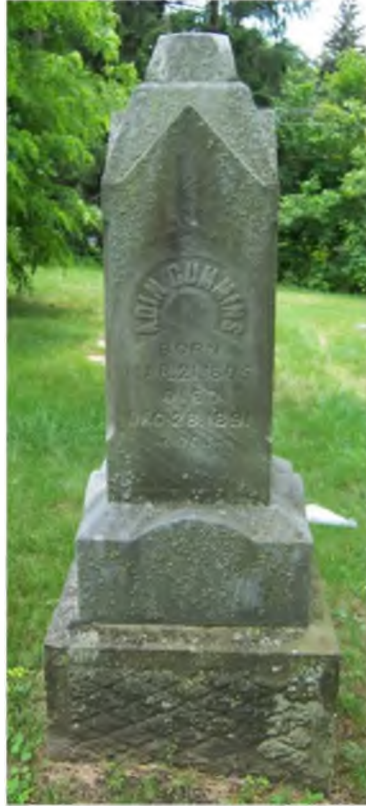
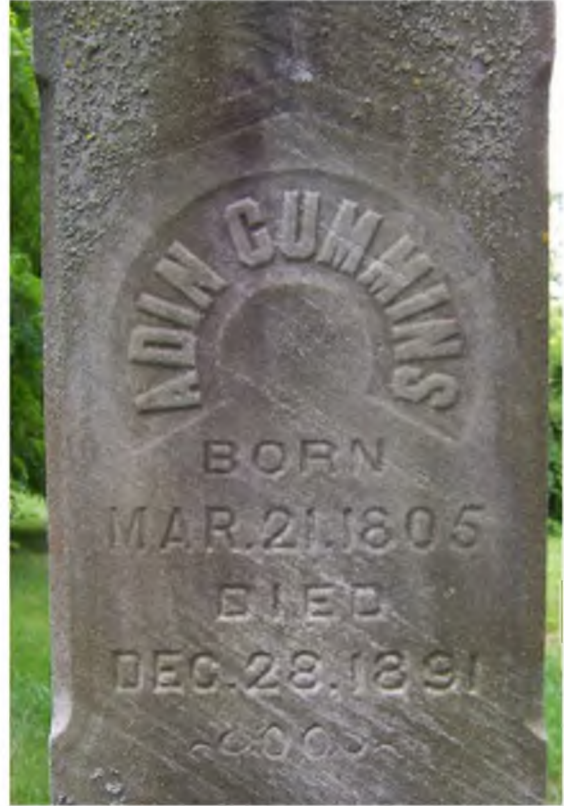
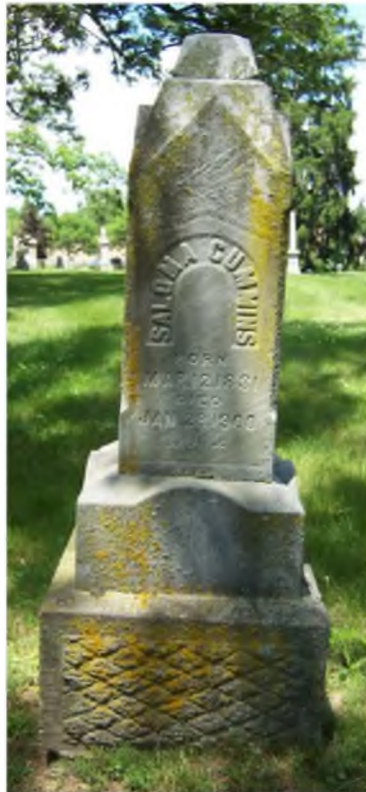
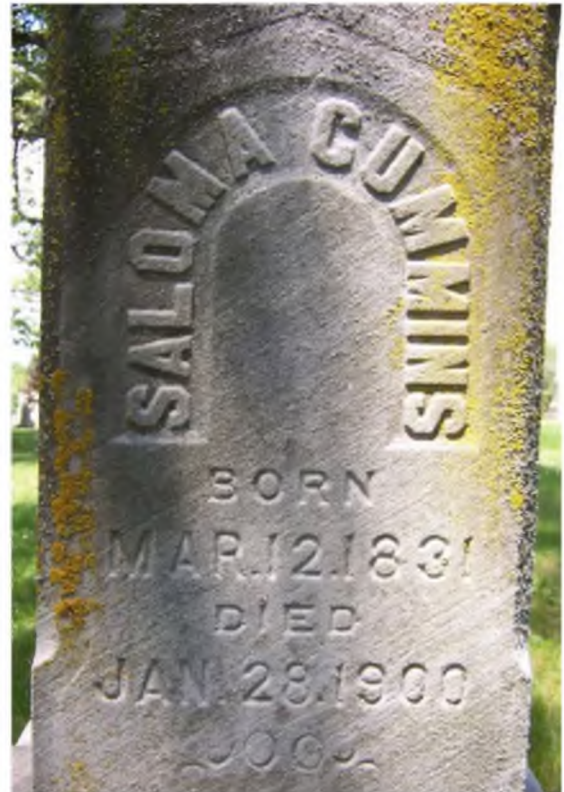
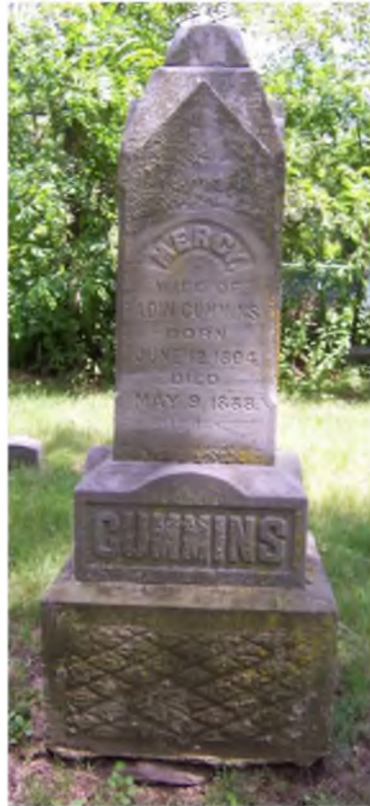
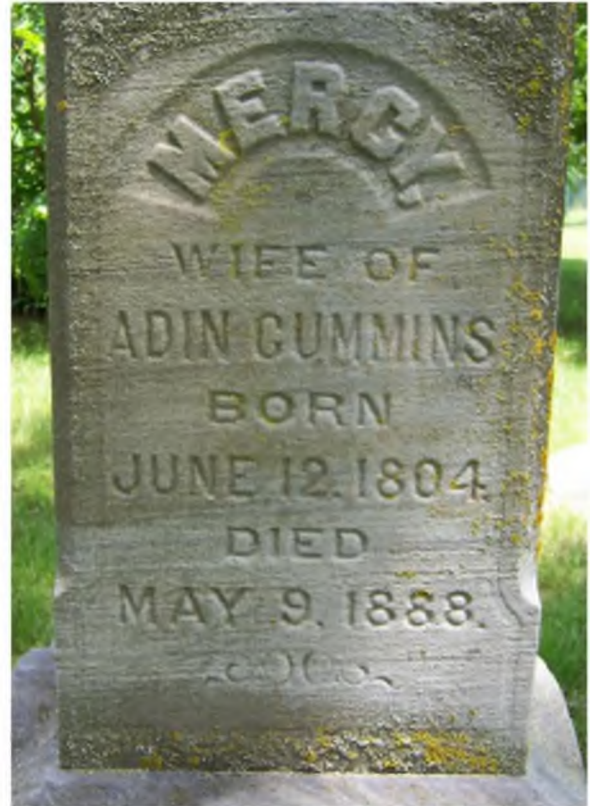
Gravestone Design Features/Motifs: sheaf of wheat above each name

- Sound
- Weathered
- Vandalized
- Leaning in Ground
- Missing (base only)
- Mower Scars
- Other (describe): Section 2 is shifted on Section 3.
- Stained / Discolored
- Cracked
- Unattached to Base
- Repaired
- Loose (not in ground, but marks grave)
- Portions Missing (list): Some kind of ornament is missing from the top.
- Buried
- Broken—# of pieces:
- Overgrown (grass / groundcover)
- Biological (moss / lichen covered)
- Displaced (not marking grave)

pedestal tomb - cap

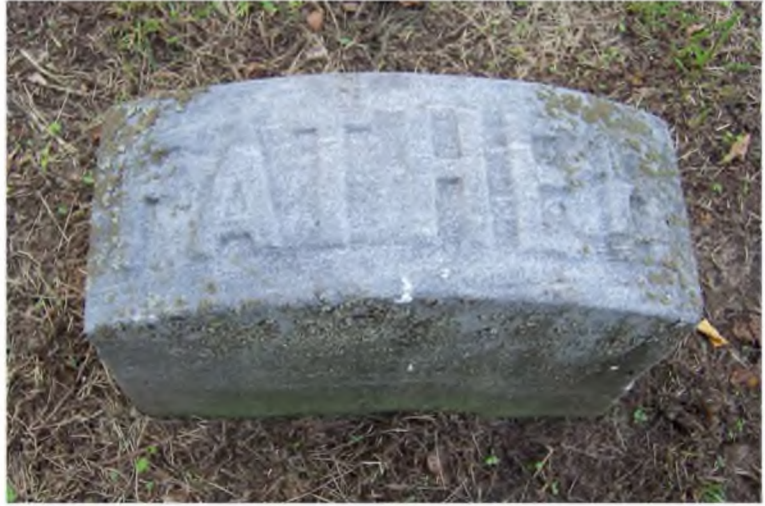
Marker # 243A

| <input checked="" type="checkbox"/> Other (describe): This marker's base is buried in front of it. | | |

“die on base”-style footstone

Remarks / Comments: The bases for all three Cummins footstones are in an approximately straight line, indicating that they are most likely still marking the graves. See also Marker 243 (Adin Cummins).

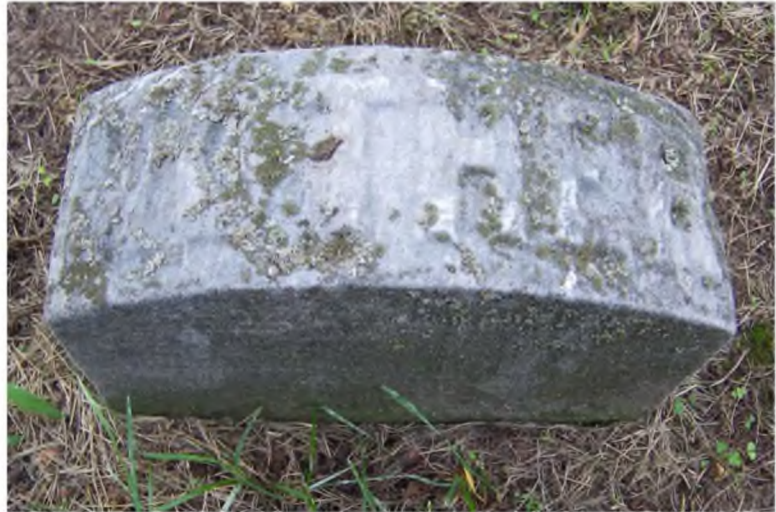
Marker # 243B

- Sound
- Weathered
- Vandalized
- Leaning in Ground
- Missing (base only)
- Mower Scars
- Other (describe): The base for this marker was found buried southeast of the marker itself.
- Stained / Discolored
- Cracked
- Unattached to Base
- Repaired
- Loose (not in ground, but marks grave)
- Portions Missing (list):
- Buried
- Broken—# of pieces:
- Overgrown (grass / groundcover)
- Biological (moss / lichen covered)
- Displaced (not marking grave)

“die on base”-style footstone

Remarks / Comments: The bases for all three Cummins footstones are in an approximately straight line, indicating that they are most likely still marking the graves. See also Marker 243 (Mercy Cummins).

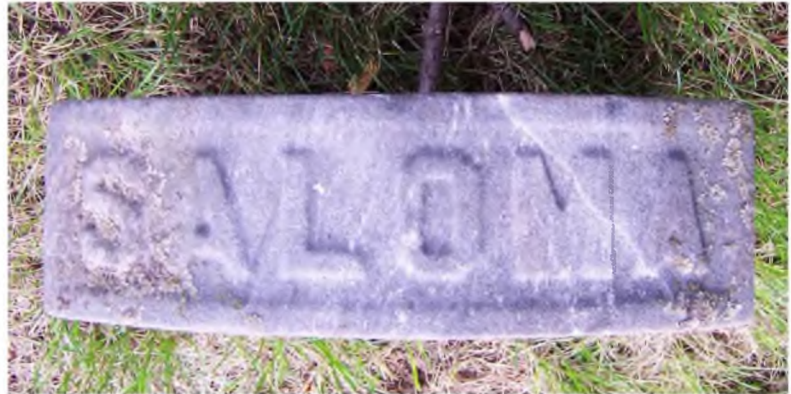
Marker # 243C

| <input checked="" type="checkbox"/> Other (describe): This marker is off its base, which is buried nearby. | | |

“die on base”-style footstone

Remarks / Comments: The bases for all three Cummins footstones are in an approximately straight line, indicating that they are most likely still marking the graves. See also Marker 243 (Saloma Cummins).
