Inscription Transcription and Photo(s):

[Children of]
 [] [Lignian]
 []
 []
 []

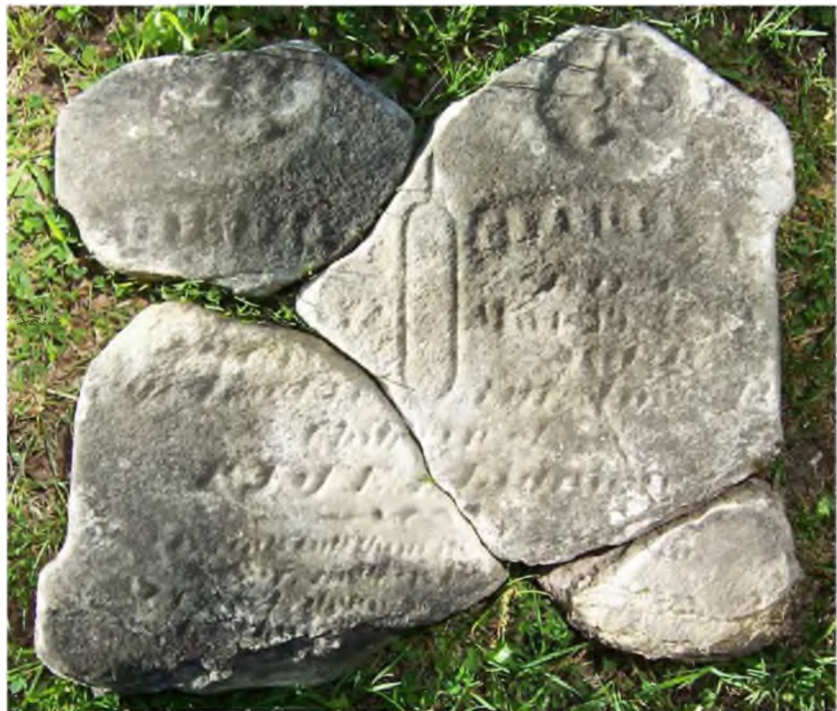
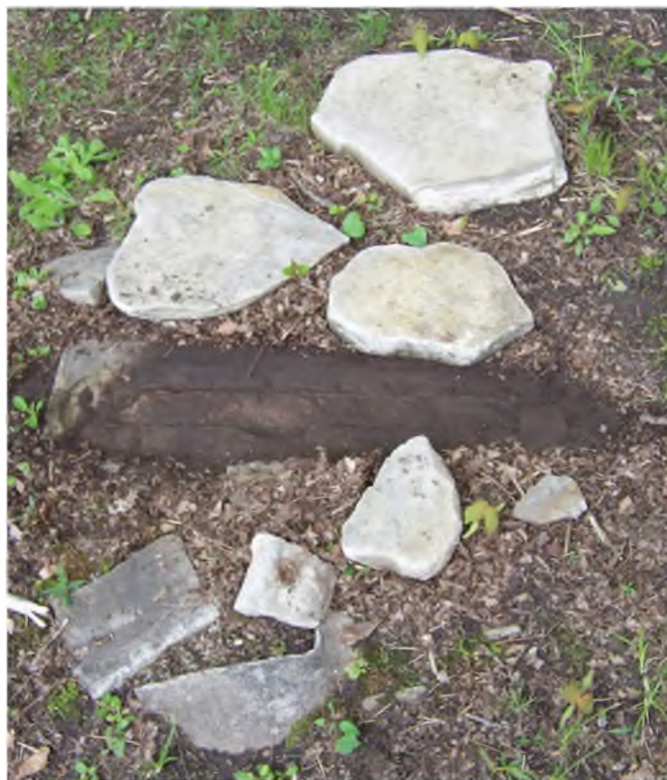
Current arrangement of pieces, with socket and broken cement repair

- Sound
- Weathered
- Vandalized
- Leaning in Ground
- Missing (base only)
- Mower Scars
- Other (describe): Marble is disintegrating.
- Stained / Discolored
- Cracked
- Unattached to Base
- Repaired
- Loose (not in ground, but marks grave)
- Portions Missing (list): There is at least one piece missing from the bottom of this marker.
- Buried
- Broken—# of pieces: 5 found
- Overgrown (grass / groundcover)
- Biological (moss / lichen covered)
- Displaced (not marking grave)

Remarks / Comments: The base of this marker is still in its socket. The original orientation of this marker cannot be determined because there is (a) piece(s) missing between the existing pieces and the piece in the socket.
