Inscription Transcription and Photo(s):

David H. Rowland
Died
June 11, 1860.
Aged
62 Years.

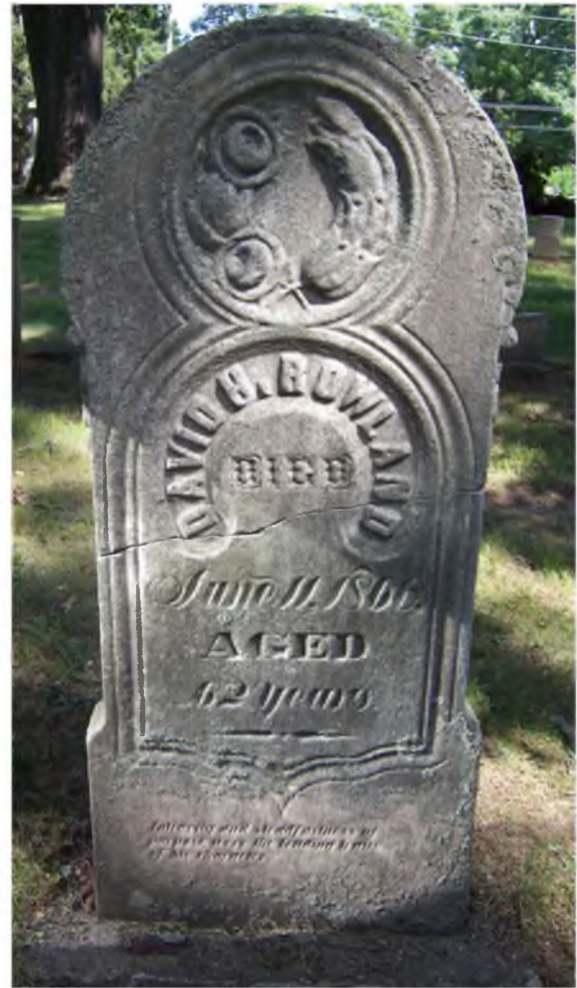
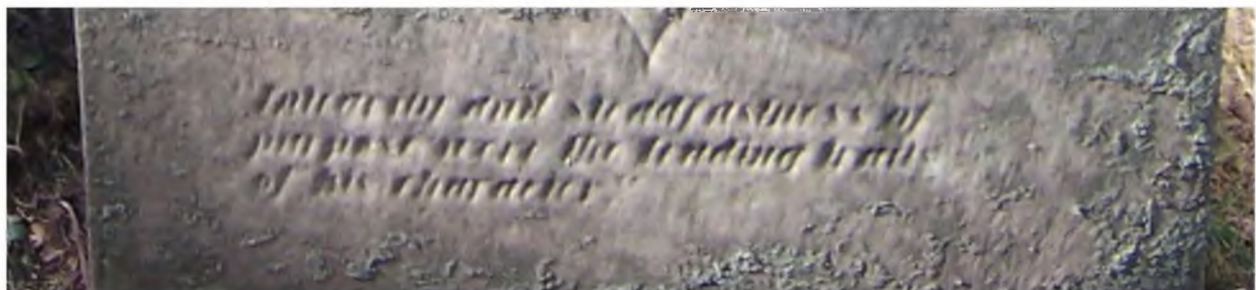
Gravestone Design Features/Motifs: floral wreath; sash draped across top of stone

Height: 55"
 Width: 24.25"
 Thickness: 4"

die in socket

semicircular arch

Previous Repairs: Caulk was used at one time to repair this stone, but it is almost worn away. Pins may also have been used, but they are not visible. The socket has been repaired with cement.
