Inscription Transcription and Photo(s):

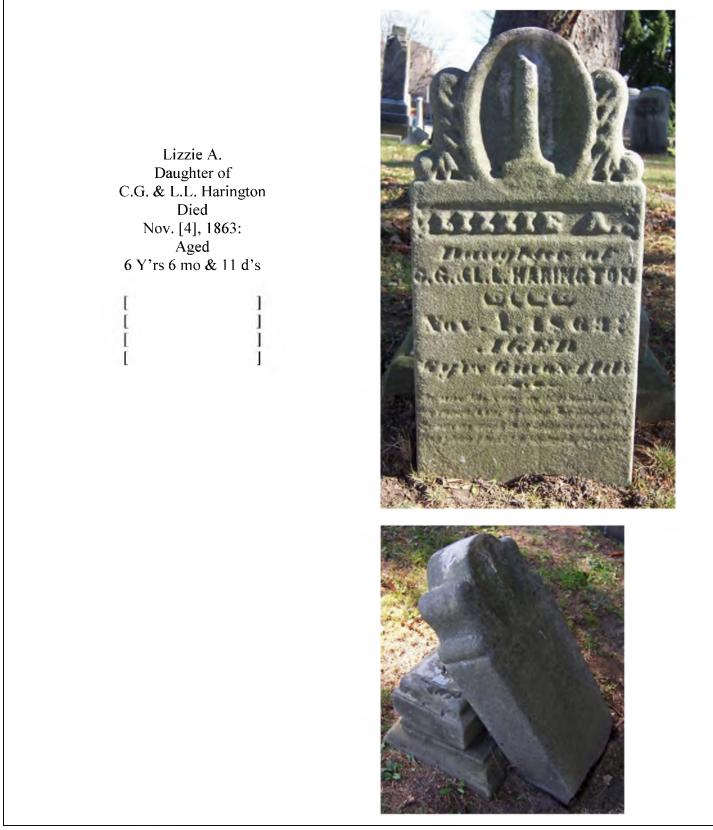
Condition of Inscription:	Inscription Technique:		
Excellent	X Incised		
Clear but worn	X Relief		
\mathbf{X} Mostly decipherable	Other (describe):		
Mostly undecipherable			
Inscription:	Stonecutter Information:		
# of individuals commemorated: 1	Stonecutter's Name: (possibly) H. Wilson		
# of carved surfaces: 1	City/State: Pontiac		
Stonecutter mark: yes	Location of Mark: bottom left of Section 2		
Gravestone Design Features/Motifs: broken pillar in an oval with wings on either side			
Material:	Gravestone Dimensions:		
\square Markla (1.2) \square Cranita	$1 \cdot 20^{10} + 14^{10} + 6^{1$

\mathbf{X} Marble (1, 2)	Granite	1: 30"h x 14"w x 6"d
Limestone	\mathbf{X} Sandstone (3)	2: 6"h x 18.5"w x 10"d
Zinc Zinc	Other Stone/Material	3: 4"h x 22.5"w x 14"d
	(describe)	Total Height (if assembled): 40"

Sound	Stained / Discolored	Buried	
X Weathered	Cracked	Broken—# of pieces:	
Uandalized	Unattached to Base	Overgrown (grass / groundcover)	
Leaning in Ground	Repaired	Biological (moss / lichen covered)	
Missing (base only)	Loose (not in ground, but marks grave)	Displaced (not marking grave)	
Mower Scars	Portions Missing (list):		
X Other (describe): Section 1 is leaning on Sections 2 and 3. Section 2 is shifted off Section 3.
