Marker # 120

Surname(s): Phillips

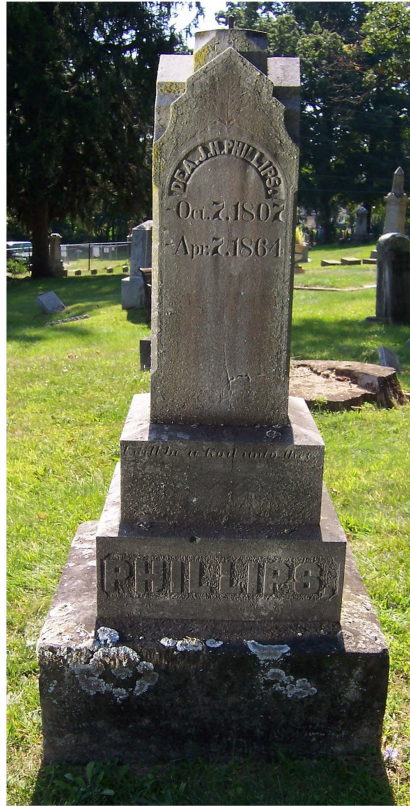
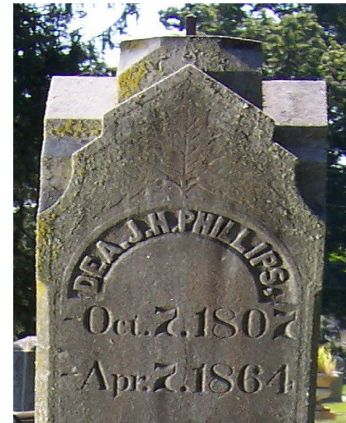
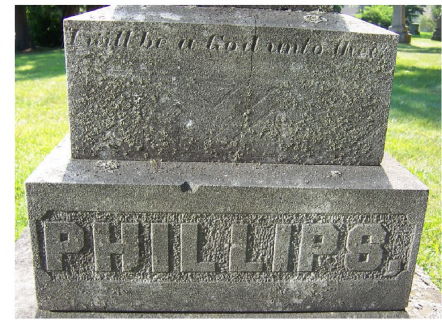
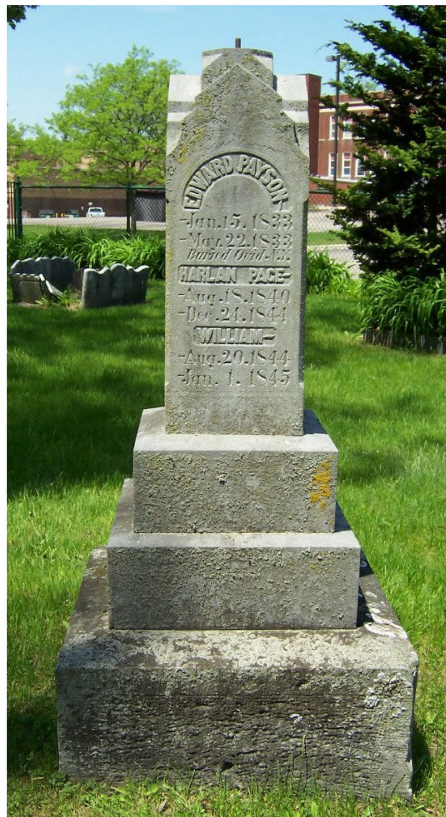
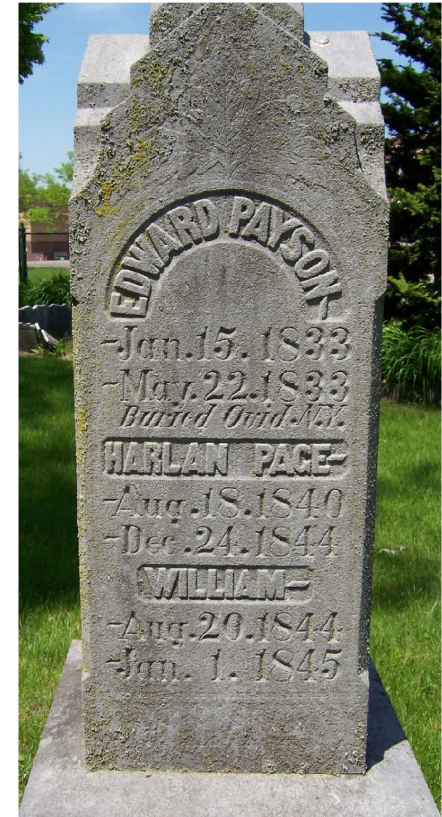
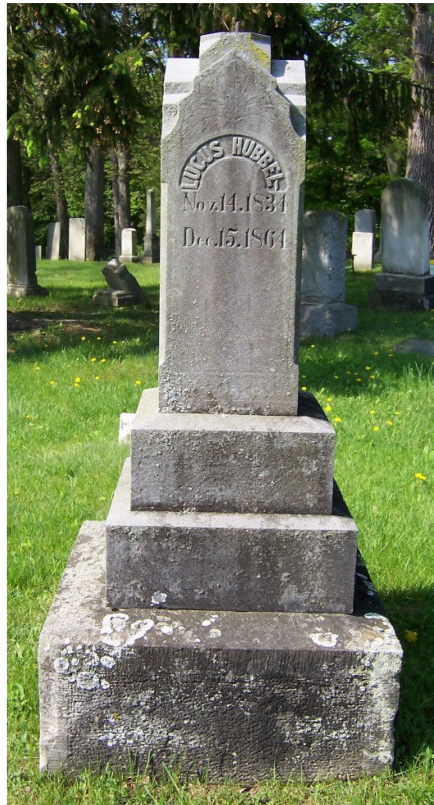
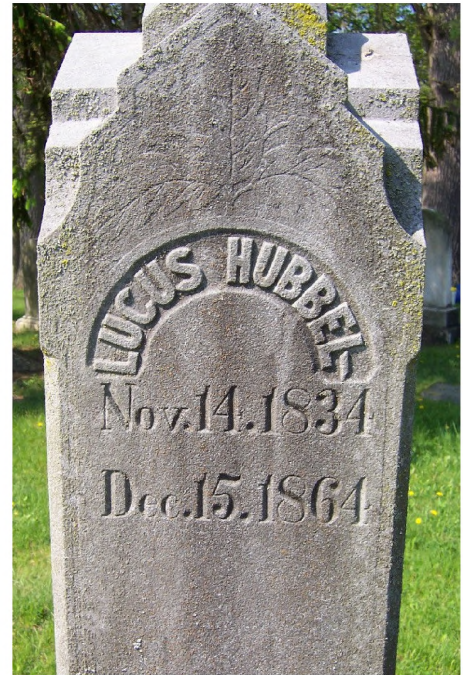
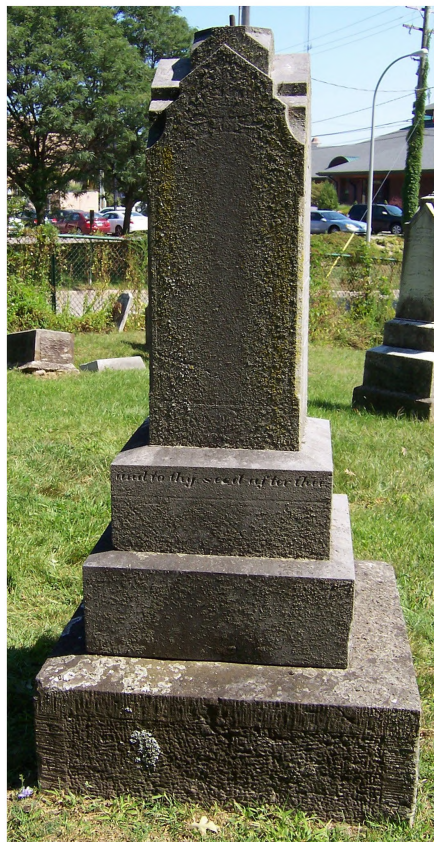
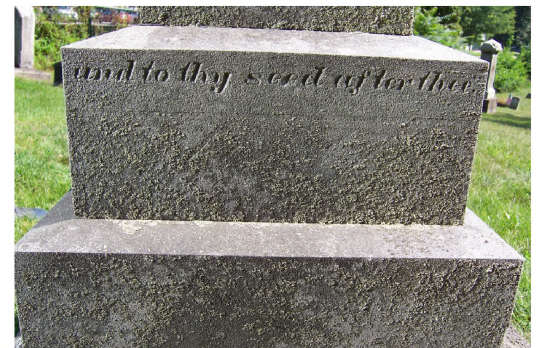
Gravestone Design Features/Motifs: three oak leaves above each of the names

- Marble (1, 2, 3)
- Limestone
- Zinc
- Granite
- Sandstone (4)
- Other Stone/Material (describe)

1: 32.5”h x 12”w x 12”d
 2: 8”h x 17.25”w x 17.25”d
 3: 8.25”h x 21.25”w x 21.25”d
 4: 12.5”h x 30”w x 30”d
 Total Height: 61.25”

- Sound
- Weathered
- Vandalized
- Leaning in Ground
- Missing (base only)
- Mower Scars
- Other (describe):
- Stained / Discolored
- Cracked
- Unattached to Base
- Repaired
- Loose (not in ground, but marks grave)
- Portions Missing (list):
- Buried
- Broken—# of pieces:
- Overgrown (grass / groundcover)
- Biological (moss / lichen covered)
- Displaced (not marking grave)

pedestal tomb - vaulted roof

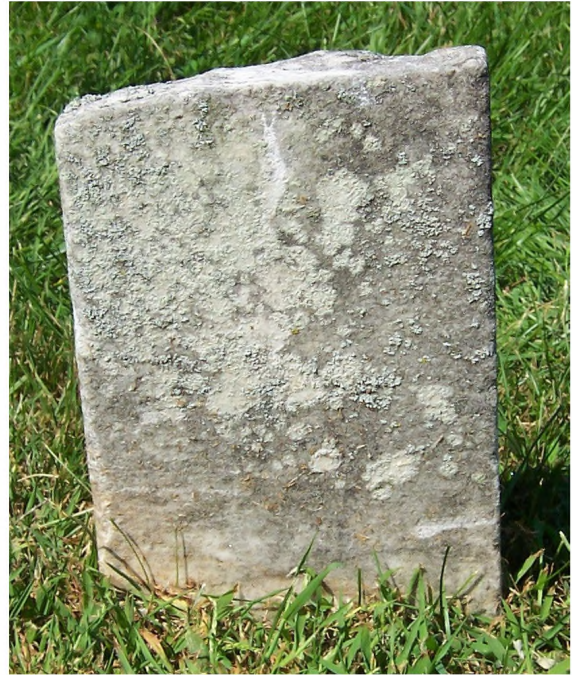
Marker # 120A

- Sound
- Weathered
- Vandalized
- Leaning in Ground
- Missing (base only)
- Mower Scars
- Other (describe): Broken across top—maybe the missing piece had a name or initials?
- Stained / Discolored
- Cracked
- Unattached to Base
- Repaired
- Loose (not in ground, but marks grave)
- Portions Missing (list): Top portion of stone
- Buried
- Broken—# of pieces: 1 found
- Overgrown (grass / groundcover)
- Biological (moss / lichen covered)
- Displaced (not marking grave)

headstone-style footstone

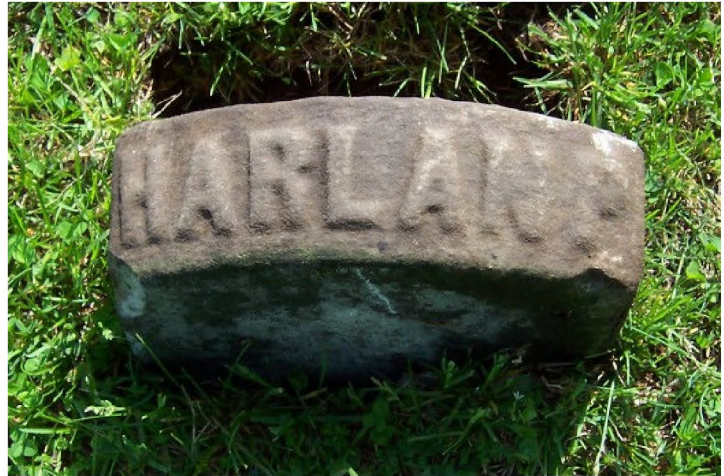
Marker # 120B

“die in socket”-style footstone

Previous Repairs: The stone has been cemented into its socket in the past, but it is now unattached.

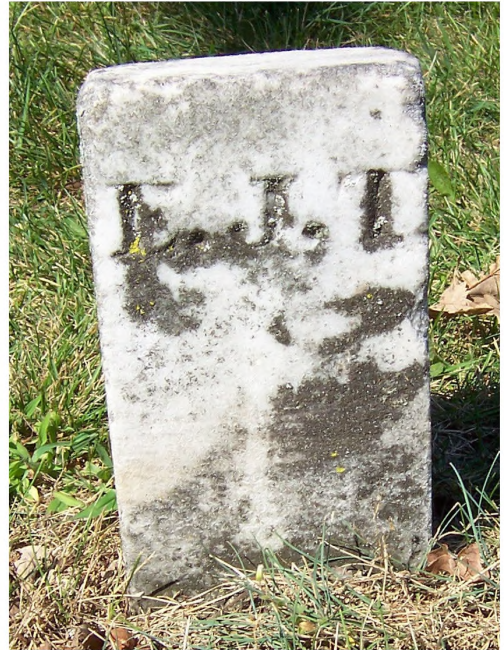
Marker # 120C

| <input checked="" type="checkbox"/> Weathered | <input type="checkbox"/> Cracked | <input type="checkbox"/> Broken—# of pieces: |
| <input type="checkbox"/> Leaning in Ground | <input checked="" type="checkbox"/> Repaired | <input checked="" type="checkbox"/> Biological (moss / lichen covered) |

headstone-style footstone

Previous Repairs: Stone is cemented in place.

Remarks / Comments: There is an Emma Jane Tozer who has a displaced stone in this cemetery (see Marker 54). This could be her footstone (same initials).

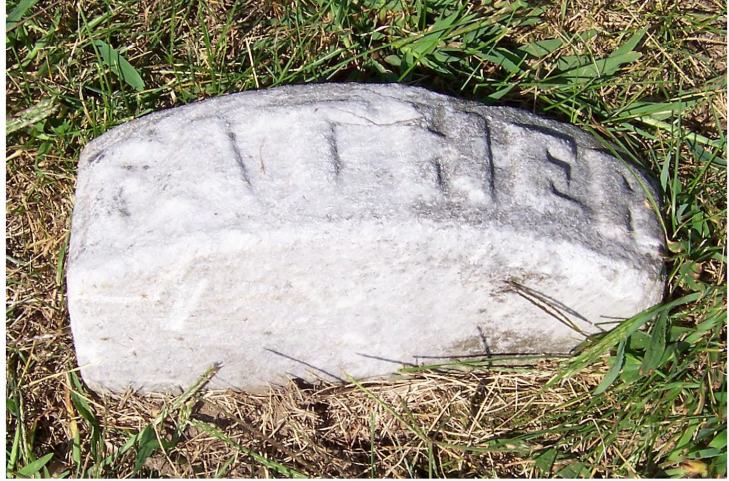
Marker # 120D

| <input checked="" type="checkbox"/> Leaning in Ground | <input checked="" type="checkbox"/> Repaired | <input type="checkbox"/> Biological (moss / lichen covered) |
| <input checked="" type="checkbox"/> Mower Scars | <input type="checkbox"/> Portions Missing (list): | |

“die in socket”-style footstone

Previous Repairs: Stone is cemented in place.

Remarks / Comments: It looks like this footstone could either be associated with Marker 120 (Dea. J. H. Phillips) or Marker 150 (one of the Fergusons).

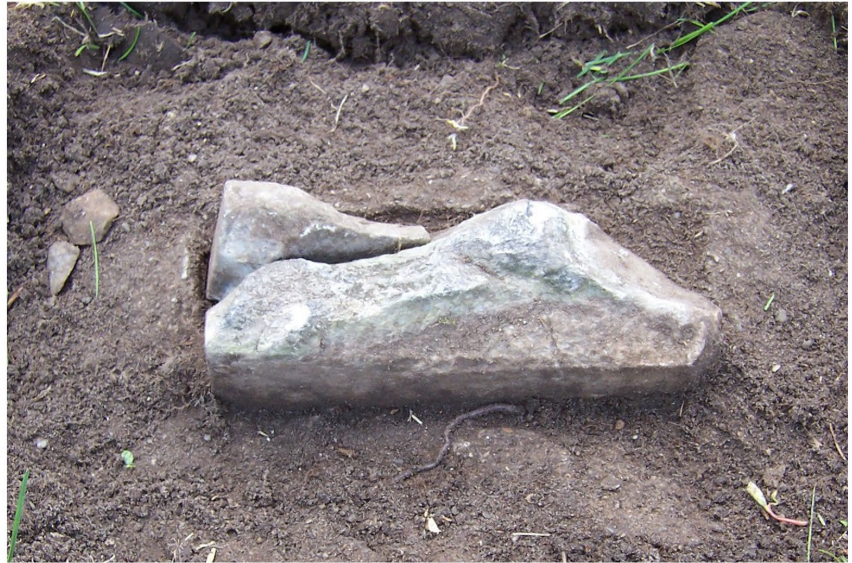
Marker # 120E

- Sound
- Weathered
- Vandalized
- Leaning in Ground
- Missing (base only)
- Mower Scars
- Other (describe):
- Stained / Discolored
- Cracked
- Unattached to Base
- Repaired
- Loose (not in ground, but marks grave)
- Portions Missing (list): The majority of this marker is missing.
- Buried
- Broken—# of pieces: 2 found
- Overgrown (grass / groundcover)
- Biological (moss / lichen covered)
- Displaced (not marking grave)

headstone

Previous Repairs: The larger piece is cemented in place. The smaller piece is loose.

Remarks / Comments: This marker base is located just north of Marker 120A.
