Marker # 151

Surname(s): Whitaker

Remarks / Comments: See also Markers 151A, 151B, 151C and 151D.

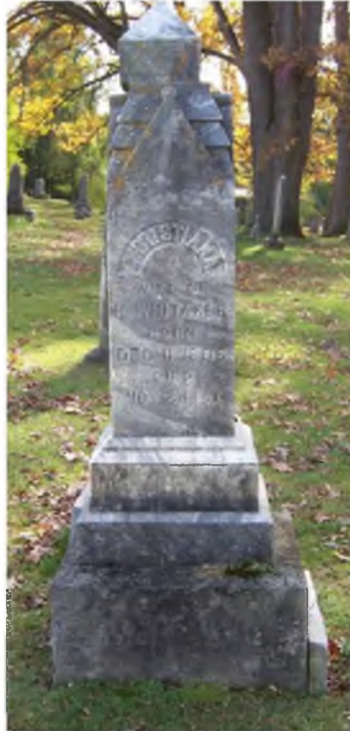
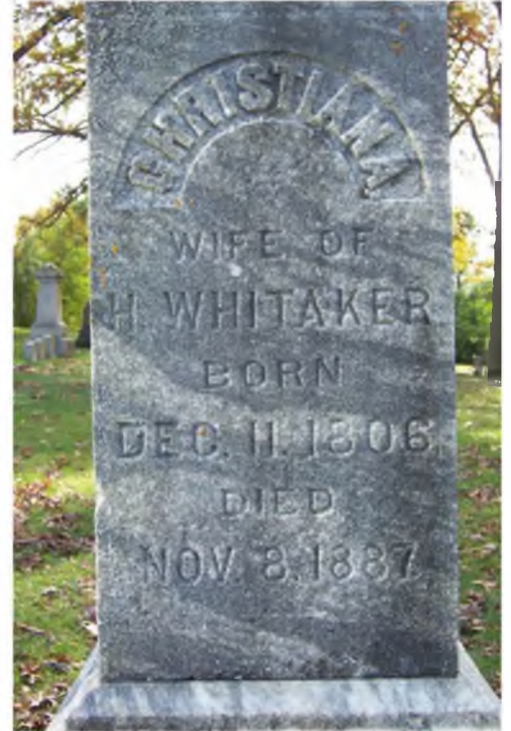
North:

Christiana
Wife of
H. Whitaker
Born
Dec. 11, 1806,
Died
Nov. 8, 1887.

- Sound
- Weathered
- Vandalized
- Leaning in Ground
- Missing (base only)
- Mower Scars
- Other (describe): Section 1 is loose on top of Section 2. All sections are sliding to the east.
- Stained / Discolored
- Cracked
- Unattached to Base
- Repaired
- Loose (not in ground, but marks grave)
- Portions Missing (list):
- Buried
- Broken—# of pieces:
- Overgrown (grass / groundcover)
- Biological (moss / lichen covered)
- Displaced (not marking grave)

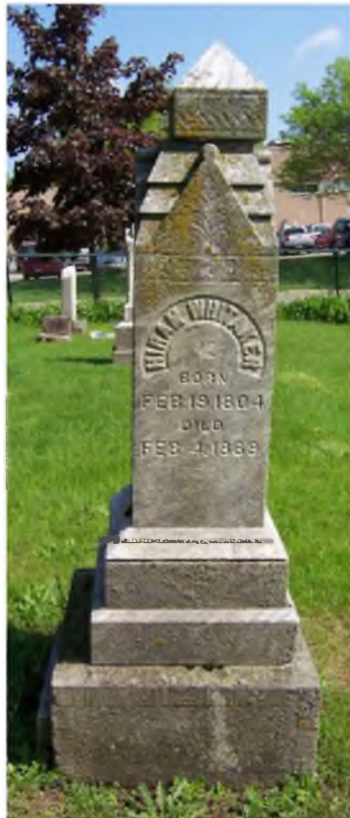
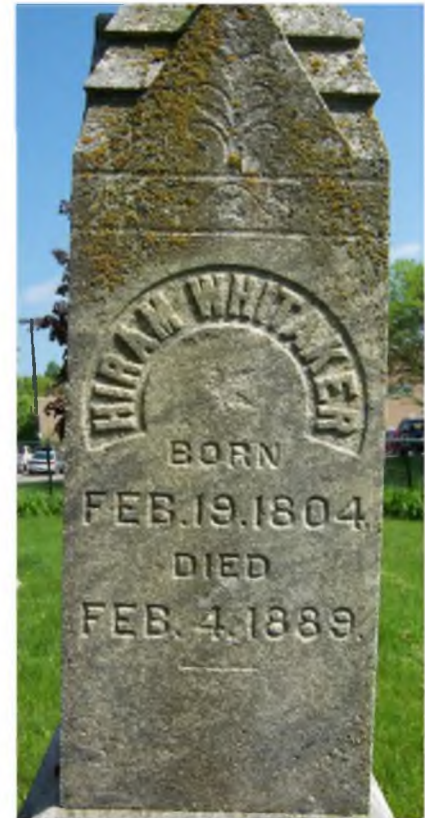
South:

Hiram Whitaker
Born
Feb. 19, 1804,
Died
Feb. 4, 1889.

- 1: 9.5”h x 9”w x 9”d
- 2: 39.5”h x 14”w x 14”d
- 3: 8”h x 19”w x 19”d
- 4: 6”h x 22”w x 22”d
- 5: 12”h x 28”w x 28.25”d
- Total Height: 75”

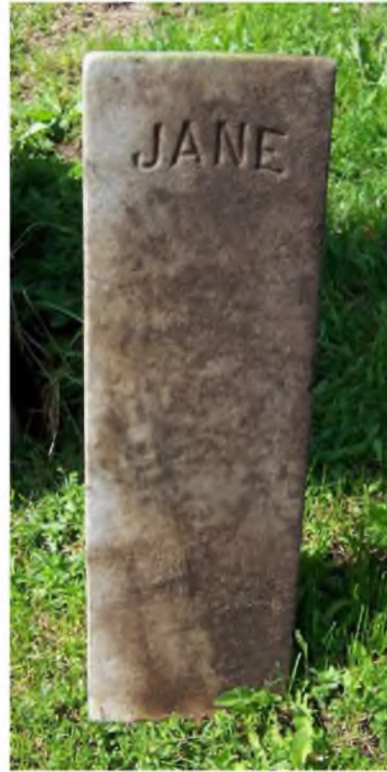
Marker # 151A

Jane

Height: 23"
 Width: 7.5"
 Thickness: 2"

- Sound
- Weathered
- Vandalized
- Leaning in Ground
- Missing (base only)
- Mower Scars
- Other (describe): Stone is leaning against Marker 151.
- Stained / Discolored
- Cracked
- Unattached to Base
- Repaired
- LOOSE (not in ground, but marks grave)
- Portions Missing (list):
- Buried
- Broken—# of pieces:
- Overgrown (grass / groundcover)
- Biological (moss / lichen covered)
- Displaced (not marking grave)

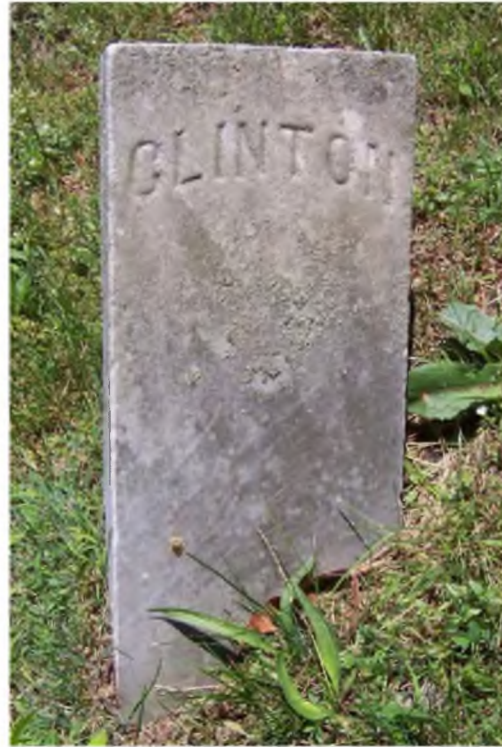
Marker # 151B

West:
Clinton

Height: 17"
 Width: 7.75"
 Thickness: 2.25"

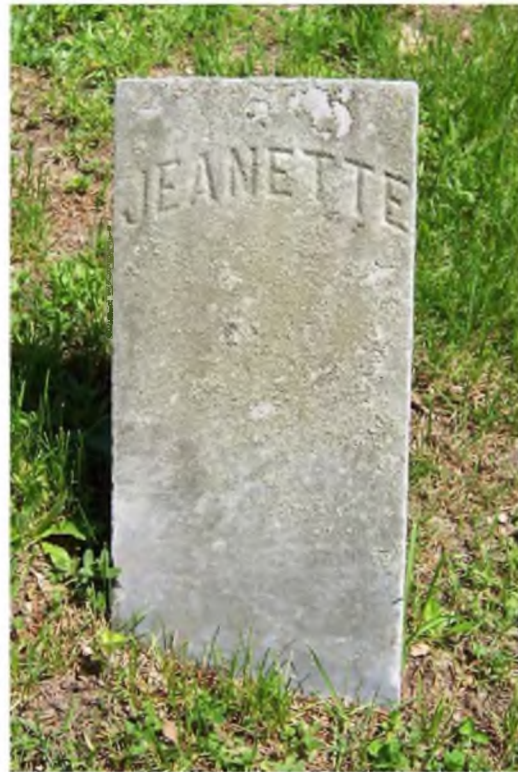
Marker # 151C

Jeanette

Height: 15"
 Width: 8"
 Thickness: 2"

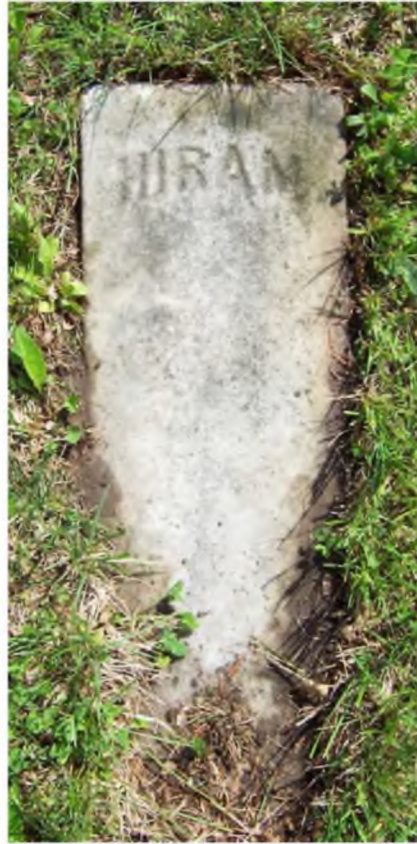
Marker # 151D

Hiram

Height: 24.25"
 Width: 7.5"
 Thickness: 2"

- Sound
- Weathered
- Vandalized
- Leaning in Ground
- Missing (base only)
- Mower Scars
- Other (describe): The stone is intact and out of the ground. Unknown how close it is to marking the actual grave location.
- Stained / Discolored
- Cracked
- Unattached to Base
- Repaired
- ? Loose (not in ground, but marks grave)
- Portions Missing (list):
- Buried
- Broken—# of pieces:
- Overgrown (grass / groundcover)
- Biological (moss / lichen covered)
- Displaced (not marking grave)
