Marker # 277

pedestal tomb

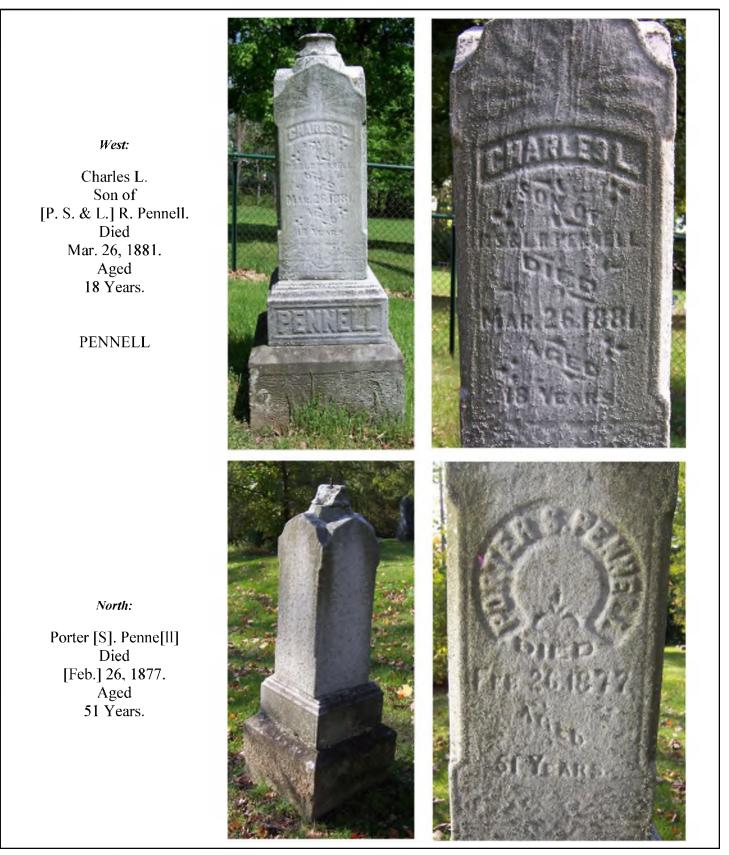
Condition of Inscription	: Inscrip	tion Technique:		
Excellent	x I	ncised		
Clear but worn		X Relief		
x Mostly decipherable		Other (describe):		
Mostly undecipher	able			
Inscription:

# of individuals co	mmemorated: 2			
# of carved surface	es: 2			
Stonecutter mark:	no			
Gravestone Design Features/Motifs: sheaf of wheat?				
Material:	G	Fravestone Dimensions:		
X Marble (1, 2, 3)	Granite	1: 3"h x 6"w x 6"d		
Limestone	\boxed{X} Sandstone (4)	2: 29.5"h x 12"w x 12"d		
Limestone Zinc	Other Stone/Material

Mower Scars	Portions Missing (list):	Some kind of ornament is missing from the top.

\square Other (describe): Section 1 is loose and broken. Section 2 is shifted on Section 3.
