Marker # 320

Surname(s): Johnson

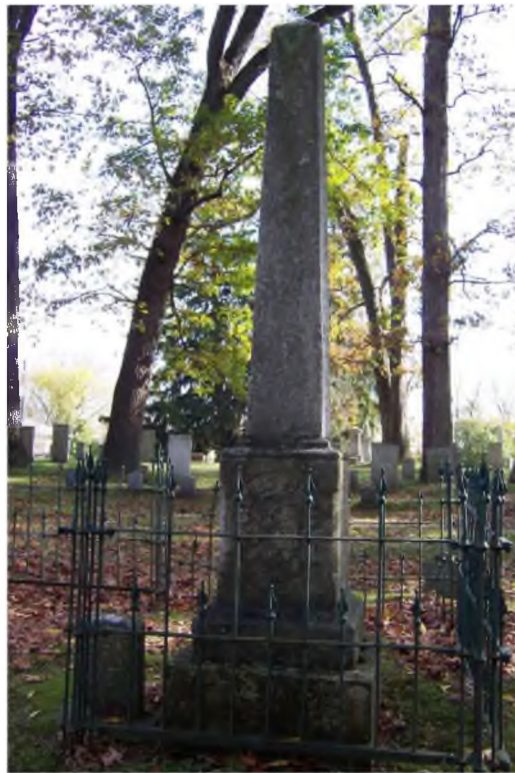
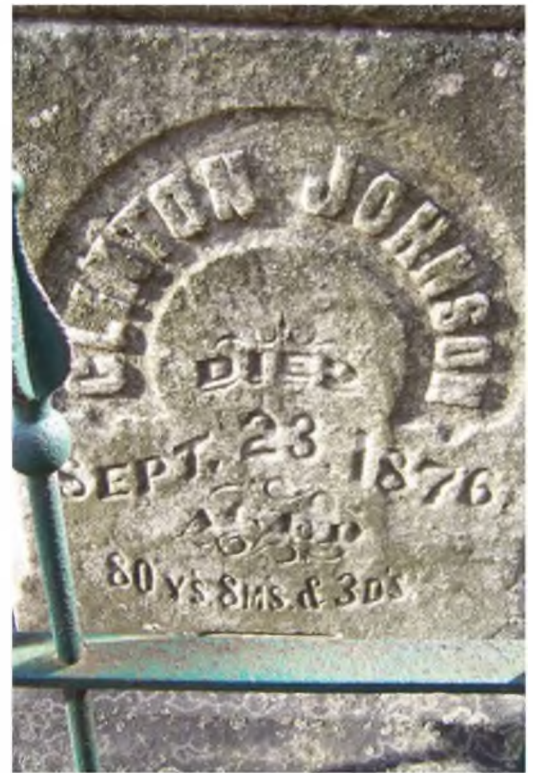
West:

Clinton Johnson
Died
Sept. 23, 1876
Aged
80 Y's. 8 M's. & 3 D's

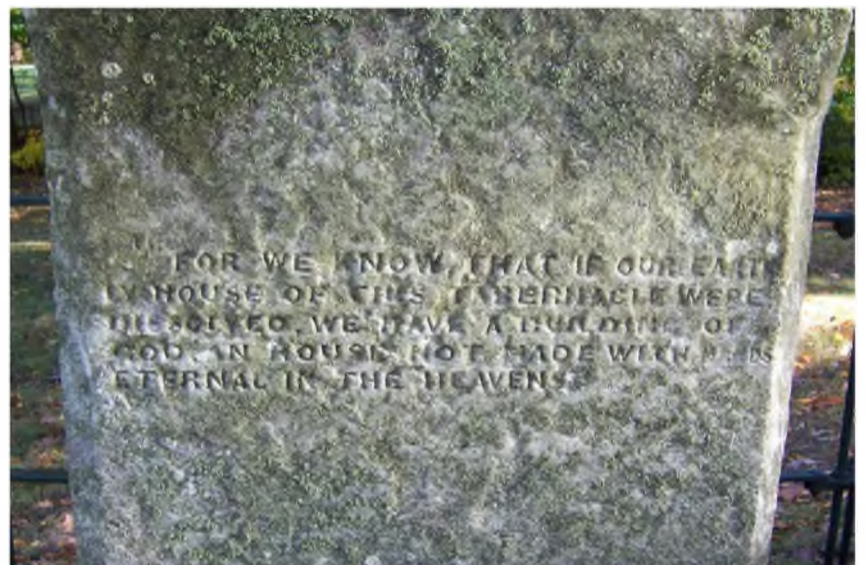
East:

For we know that if our earth
[ly] house of this tabernacle were
[dis]solved, we have a [building] of
God, an house not made with [hands]
eternal in the heavens.

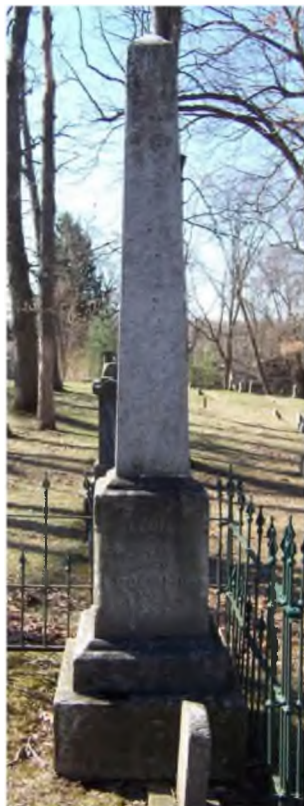
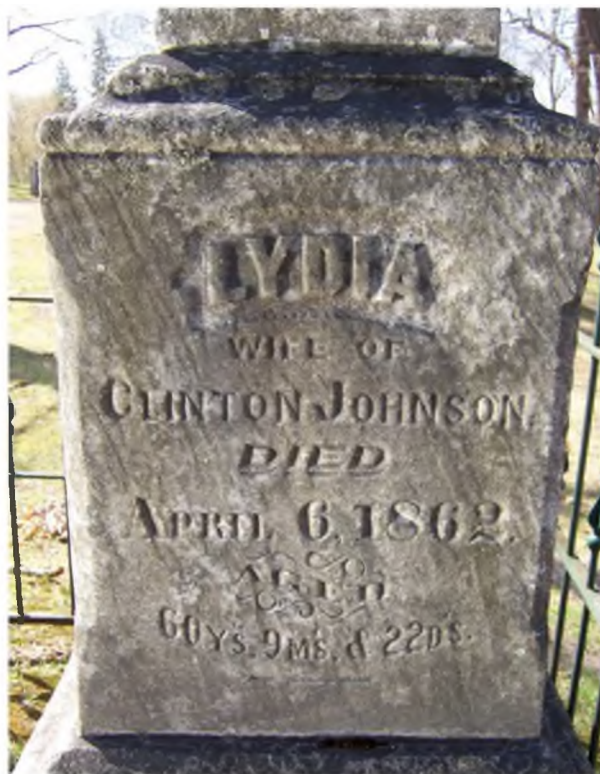
North :

Lydia
Wife of
Clinton Johnson
Died
April 6, 1862
Aged
60 Y's. 9 M's. & 22 D's.

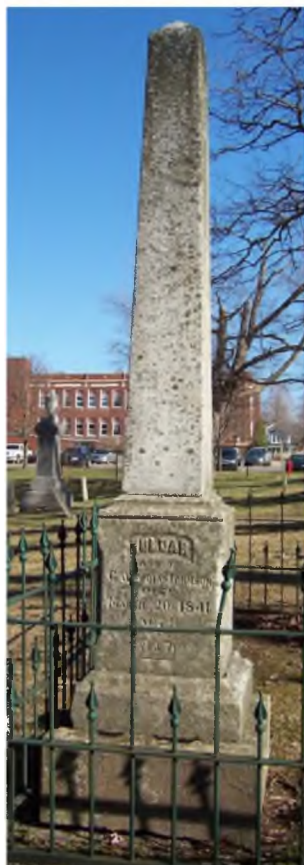
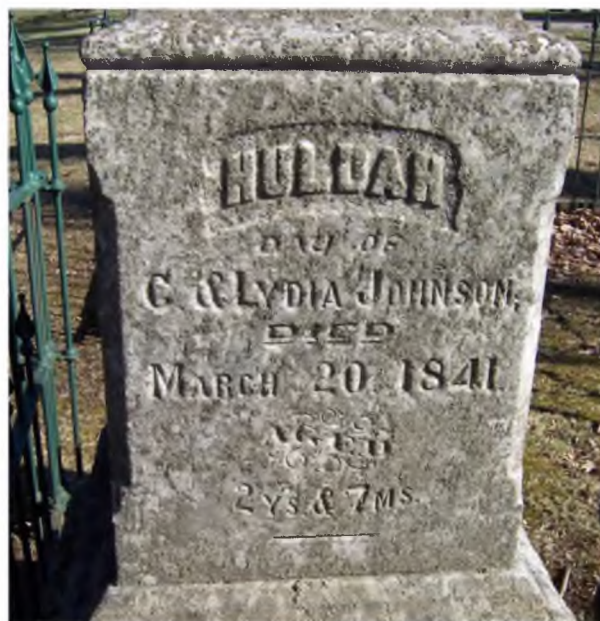
South:

Huldah
Dau of
C. & Lydia Johnson.
Died
March 20, 1841
Aged
2 Y's & 7 M's.

1: 71.5”h x 12”w x 12”d
 2: 25”h x 18”w x 18”d
 3: 7.5”h x 24”w x 24”d
 4: 13”h x 29.5”w x 29.5”d
 Total Height: 117”

- Sound
- Weathered
- Vandalized
- Leaning in Ground
- Missing (base only)
- Mower Scars
- Other (describe): Section 1 is shifted on Section 2.
- Stained / Discolored
- Cracked (Section 3)
- Unattached to Base
- Repaired
- Loose (not in ground, but marks grave)
- Portions Missing (list):
- Buried
- Broken—# of pieces:
- Overgrown (grass / groundcover)
- Biological (moss / lichen covered)
- Displaced (not marking grave)

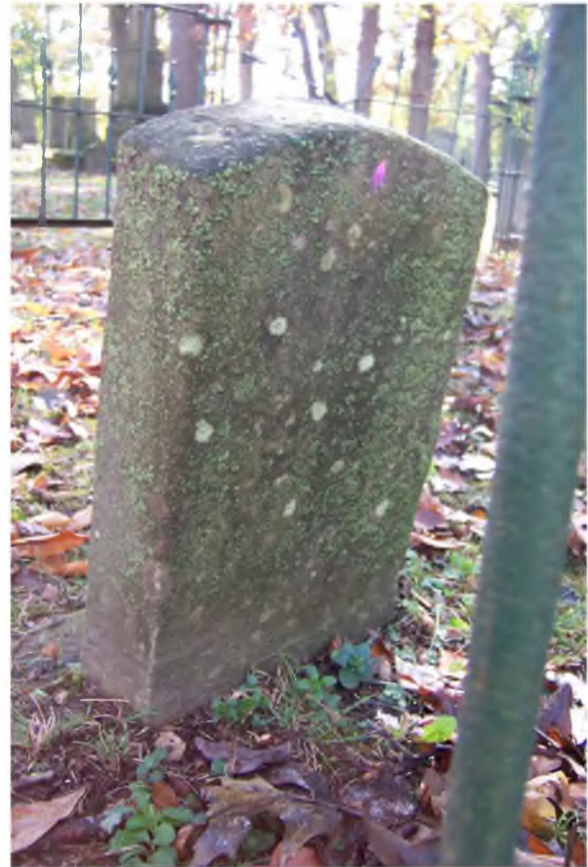
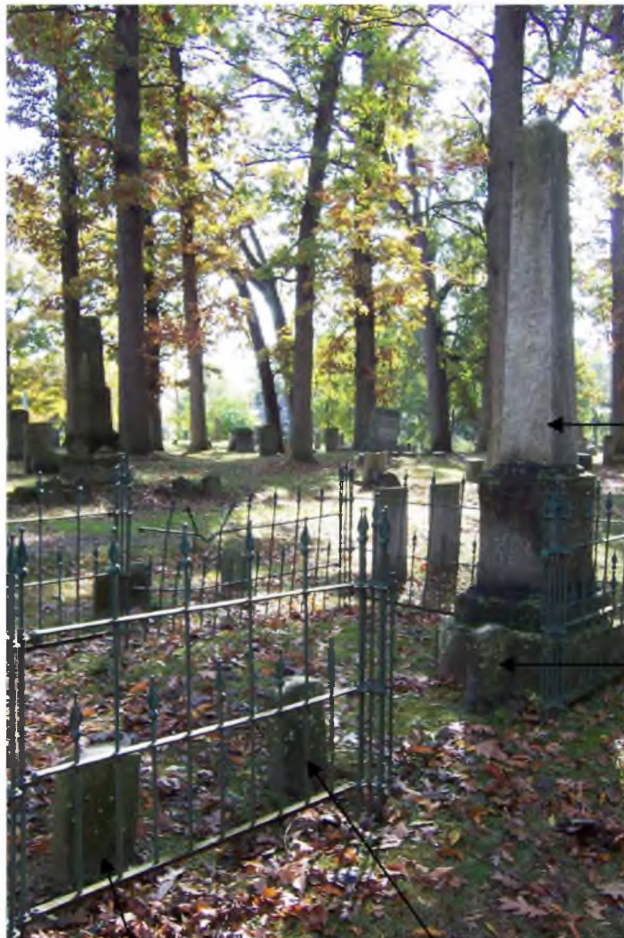
Marker # 320A

Condition of Inscription: none visible

Height: 16"

Width: 10.25"

Thickness: 3"

| <input type="checkbox"/> Leaning in Ground | <input type="checkbox"/> Repaired | <input checked="" type="checkbox"/> Biological (moss / lichen covered) |

“die in socket”-style footstone

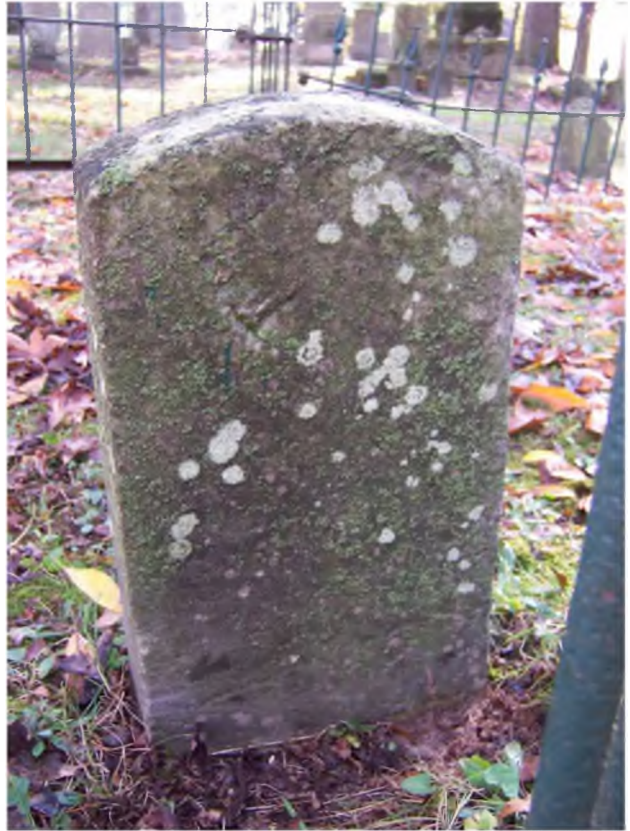
Marker # 320B

Condition of Inscription: none visible

Height: 16.75"

Width: 10.25"

Thickness: 3"

“die in socket”-style footstone

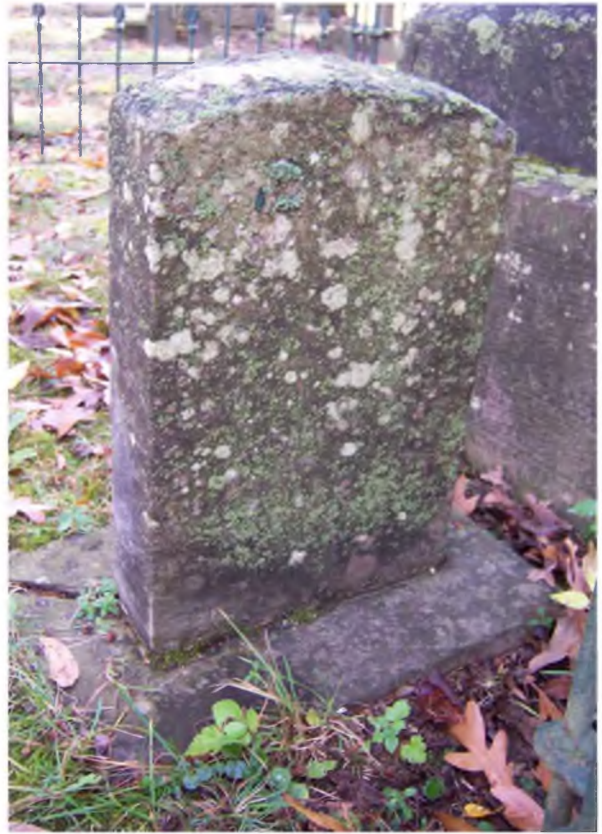
Marker # 320C

Condition of Inscription: none visible

Height: 15.5"

Width: 10.25"

Thickness: 3"

“die in socket”-style footstone
