Marker # 73

Surname(s): Pudney

Inscription Transcription and Photo(s):

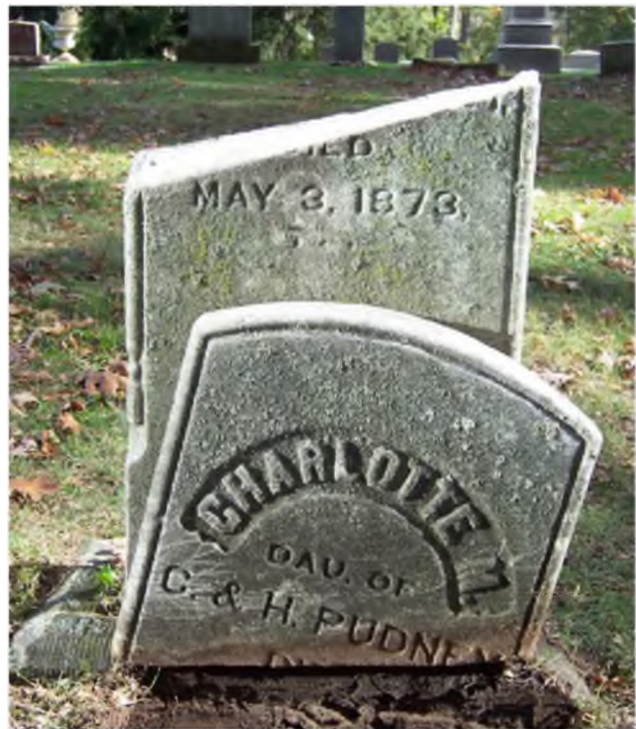
Charlotte M.
Dau. Of
C. & H. Pudne[y]
[Die]d
May 3, 1873.

Gravestone Design Features/Motifs: marker is draped by a cord with tassels on either side

| <input type="checkbox"/> Weathered | <input type="checkbox"/> Cracked | <input checked="" type="checkbox"/> Broken—# of pieces: 2 |
| <input checked="" type="checkbox"/> Mower Scars | <input type="checkbox"/> Portions Missing (list): | |
| <input checked="" type="checkbox"/> Other (describe): The stone is in two pieces, with the lower half still in place in the ground. | | |
