Marker # 81

Surname(s): Curtis

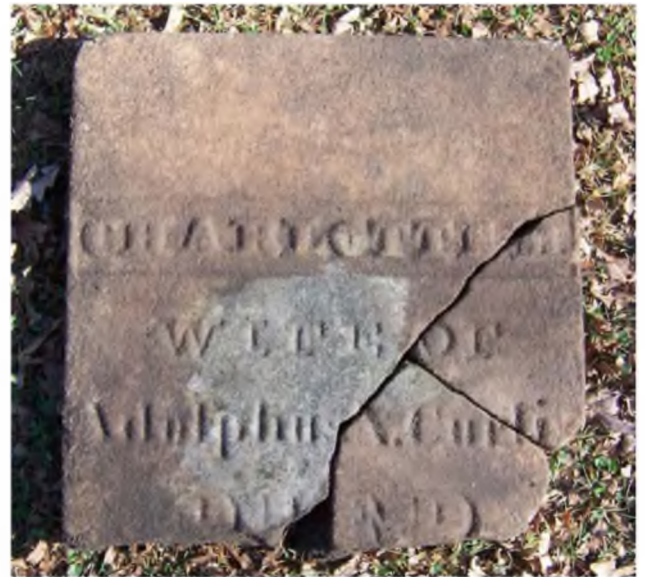
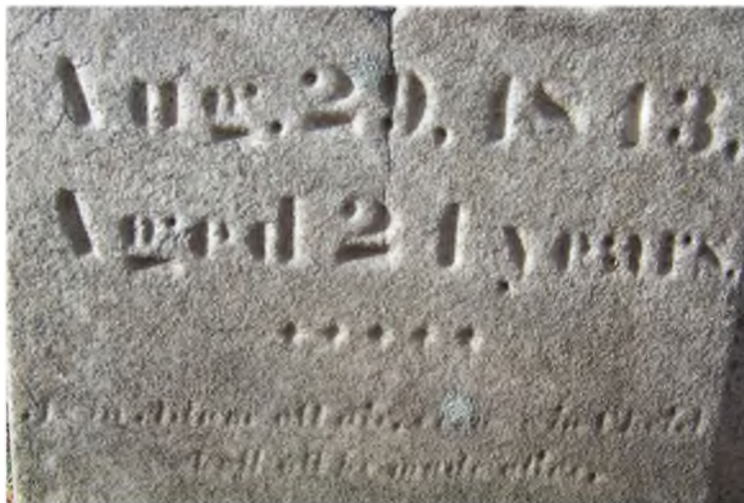
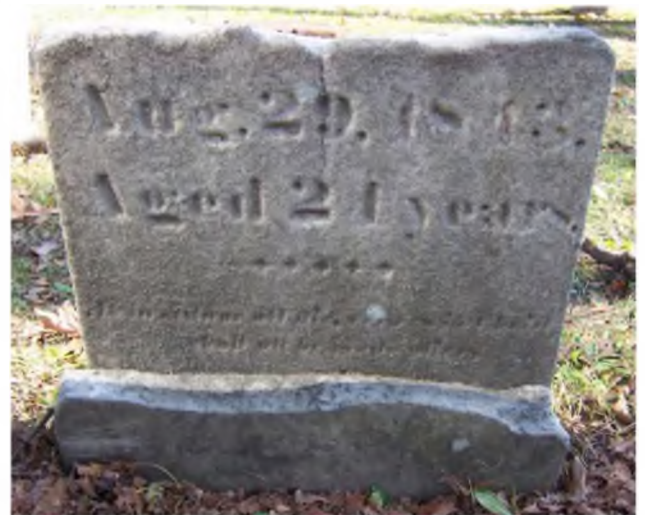
- Sound
- Weathered
- Vandalized
- Leaning in Ground
- Missing (base only)
- Mower Scars
- Other (describe): Laminar cracking
- Stained / Discolored
- Cracked
- Unattached to Base
- Repaired
- Loose (not in ground, but marks grave)
- Portions Missing (list):
- Buried
- Broken—# of pieces: 5 found
- Overgrown (grass / groundcover)
- Biological (moss / lichen covered)
- Displaced (not marking grave)

Remarks / Comments: The stone is broken off near the bottom, with the base still in place in the ground. The middle section is standing upright behind the base. The top section of the stone is in at least three pieces on the ground behind the upright section.
