Inscription Transcription and Photo(s):

West:

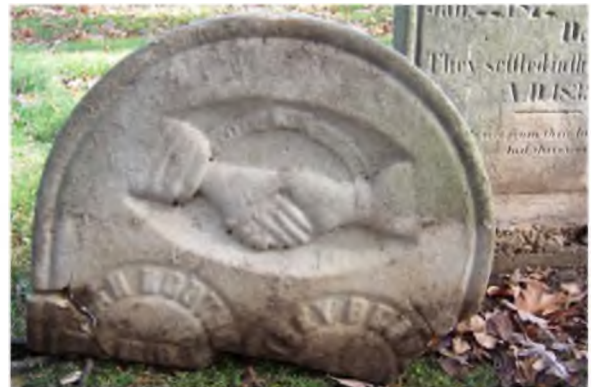
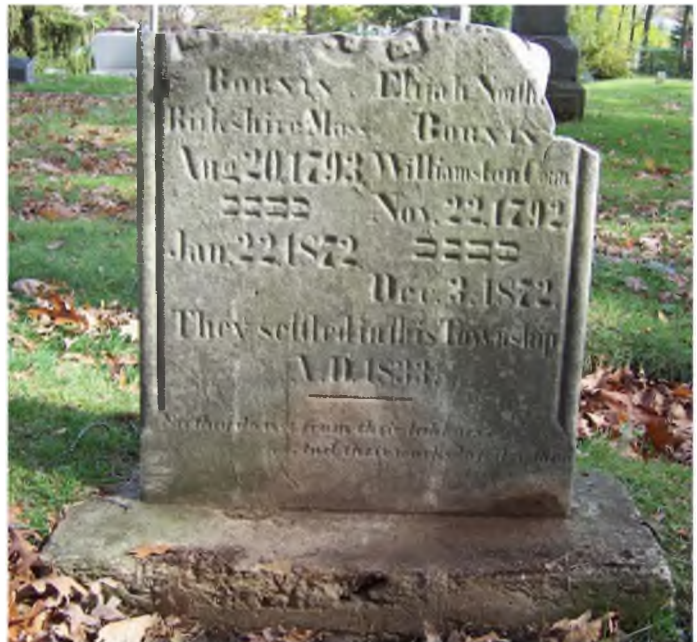
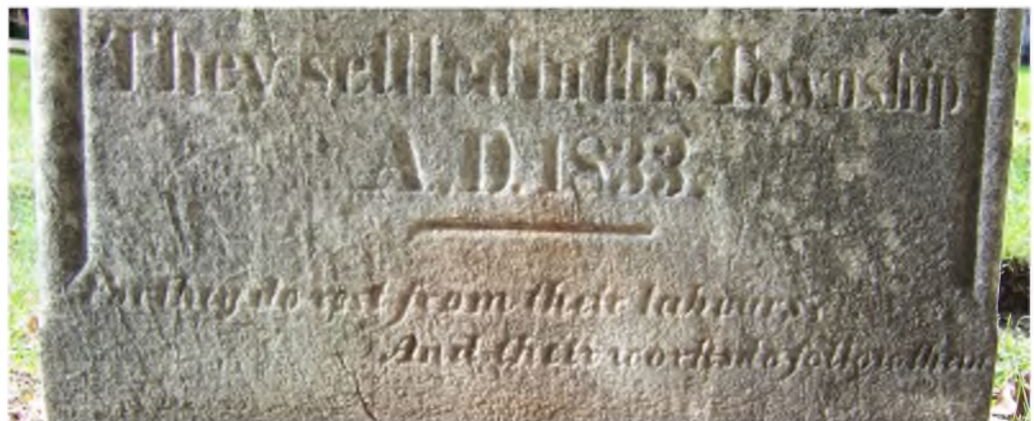
Gravestone Design Features/Motifs: holding hands with an inscribed ribbon above them; text too worn to read

Height: 43.75" (total)
 Width: 24.25"
 Thickness: 3"

- Sound
- Weathered
- Vandalized
- Leaning in Ground
- Missing (base only)
- Mower Scars
- Other (describe):
- Stained / Discolored
- Cracked
- Unattached to Base
- Repaired
- Loose (not in ground, but marks grave)
- Portions Missing (list): The upper-right corner of the lower section is missing. This could be in multiple pieces.
- Buried
- Broken—# of pieces: 3 found
- Overgrown (grass / groundcover)
- Biological (moss / lichen covered)
- Displaced (not marking grave)

Previous Repairs: The socket is cement—it must have been repaired at some point. Also, there are iron pins in the stone. They must have held an iron strap around the stone, but this strap is now gone.
