Marker # 273

Surname(s): Whitaker

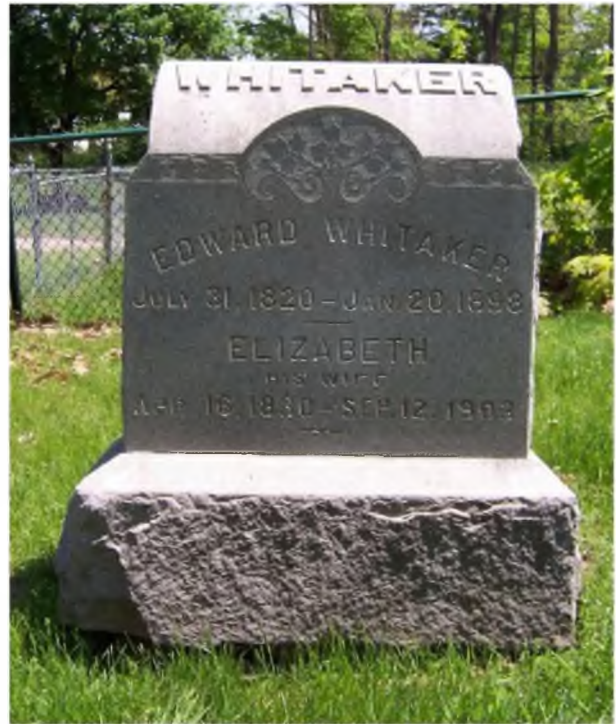
1: 30.25”h x 30.25”w x 12”d
 2: 13.5”h x 36.25”w x 18”d
 Total Height: 43.75”

| <input checked="" type="checkbox"/> Sound | <input type="checkbox"/> Stained / Discolored | <input type="checkbox"/> Buried |

die on base

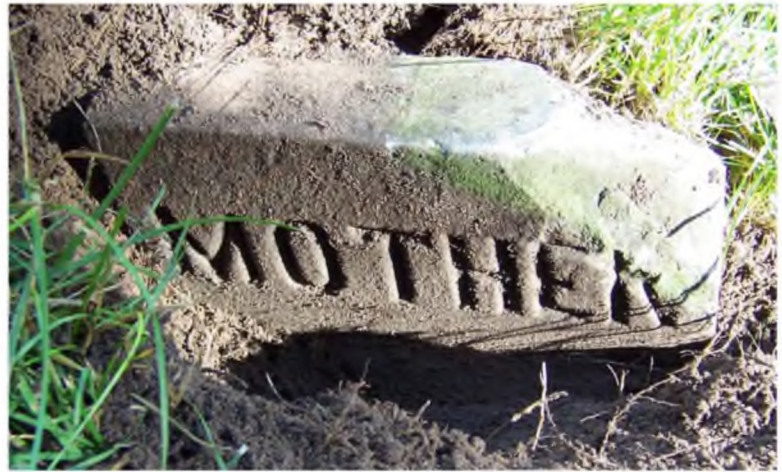
Marker # 273A

Height: 5"
 Width: 10.25"
 Thickness: 2.25"

| <input type="checkbox"/> Vandalized | <input type="checkbox"/> Unattached to Base | <input checked="" type="checkbox"/> Overgrown (grass / groundcover) |
| <input checked="" type="checkbox"/> Leaning in Ground | <input type="checkbox"/> Repaired | <input type="checkbox"/> Biological (moss / lichen covered) |
| <input checked="" type="checkbox"/> Mower Scars | <input checked="" type="checkbox"/> Portions Missing (list): The top right corner is missing due to mower damage. | |

headstone-style footstone

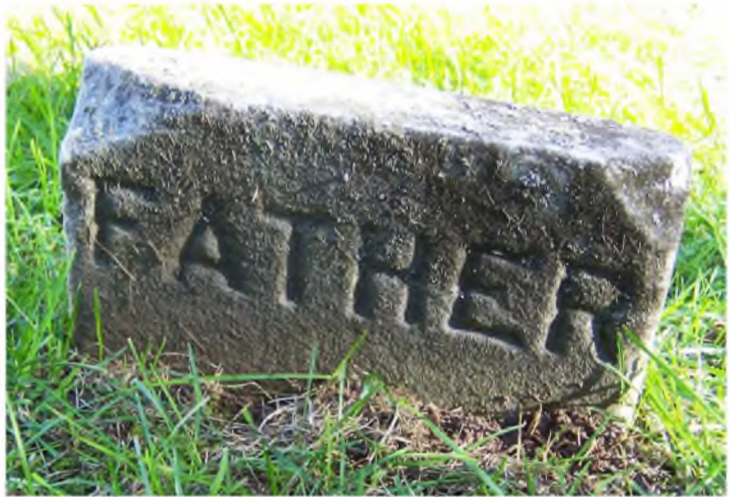
Marker # 273B

Height: 6"
 Width: 10"
 Thickness: 2"

| <input checked="" type="checkbox"/> Leaning in Ground | <input type="checkbox"/> Repaired | <input type="checkbox"/> Biological (moss / lichen covered) |
| <input checked="" type="checkbox"/> Mower Scars | <input checked="" type="checkbox"/> Portions Missing (list): The two corners on either side of "Father" are missing due to mower damage. | |

headstone-style footstone
