Marker # 281

Surname(s): King, Stevens

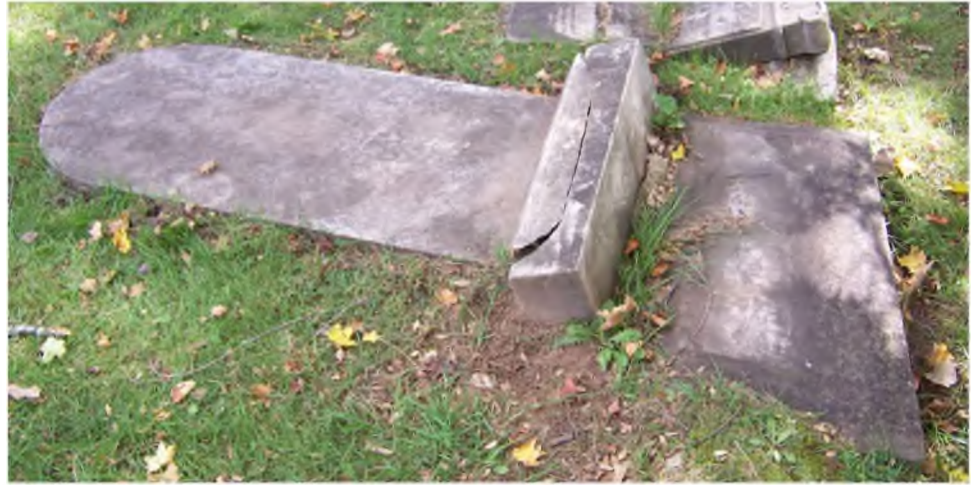
* Since this marker is currently face down, an earlier transcription has been used for identification purposes.

- Sound
- Weathered
- Vandalized
- Leaning in Ground
- Missing (base only)
- Mower Scars
- Other (describe): The marble socket is broken.
- Stained / Discolored
- Cracked
- Unattached to Base
- Repaired
- Loose (not in ground, but marks grave)
- Portions Missing (list):
- Buried
- Broken—# of pieces:
- Overgrown (grass / groundcover)
- Biological (moss / lichen covered)
- Displaced (not marking grave)
