Marker # 294

Surname(s): [Covert]

Marker # 294A

Marker # 294B

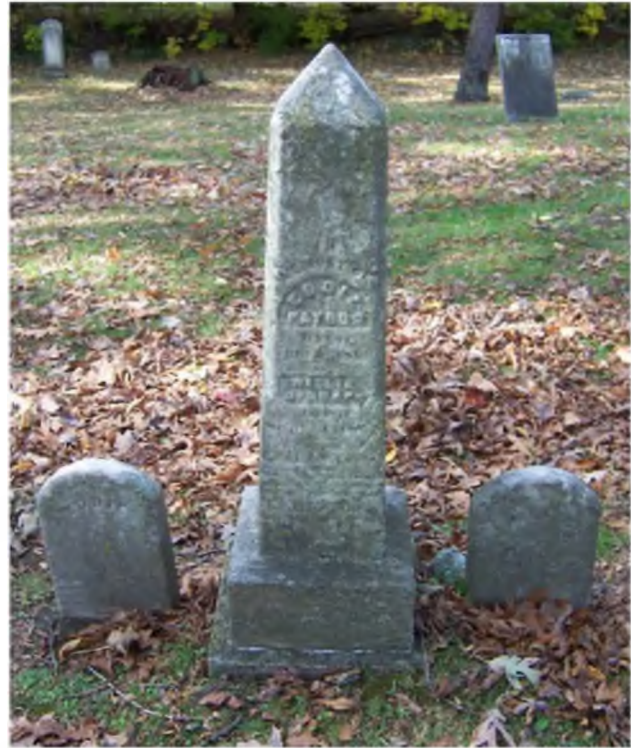
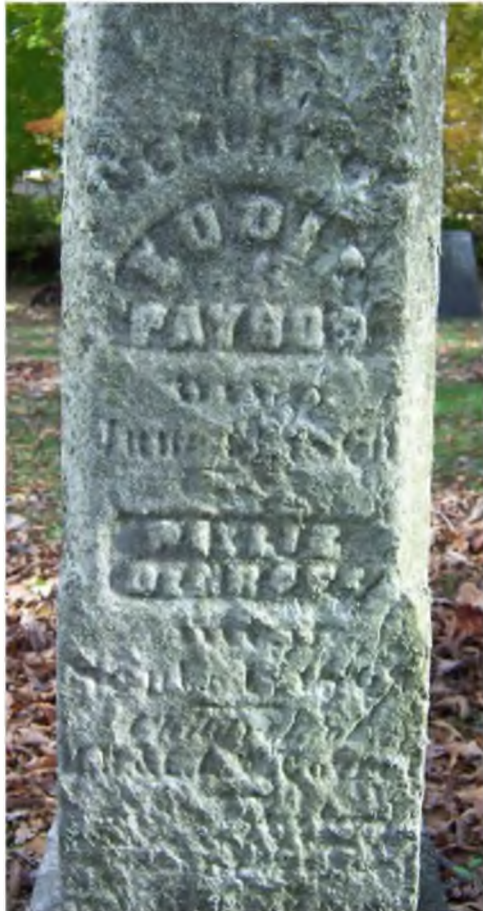
Eddi[e]
Payso[n]
[Died]
June [13], 18[60]

Willie
[DeGraff]
[Died]
[Sept. 4, 1869]

[Children of]
[J. B.] & E. A. W. Co[vert]

1: 32”h x 8.5”w x 8.5”d
 2: 6.25”h x 12.25”w x 12.25”d
 3: 4”h x 15.25”w x 15.25”d
 Total Height: 42.25”

- Sound
- Weathered
- Vandalized
- Leaning in Ground
- Missing (base only)
- Mower Scars
- Other (describe):
- Stained / Discolored
- Cracked
- Unattached to Base
- Repaired
- Loose (not in ground, but marks grave)
- Portions Missing (list):
- Buried
- Broken—# of pieces:
- Overgrown (grass / groundcover)
- Biological (moss / lichen covered)
- Displaced (not marking grave)

obelisk

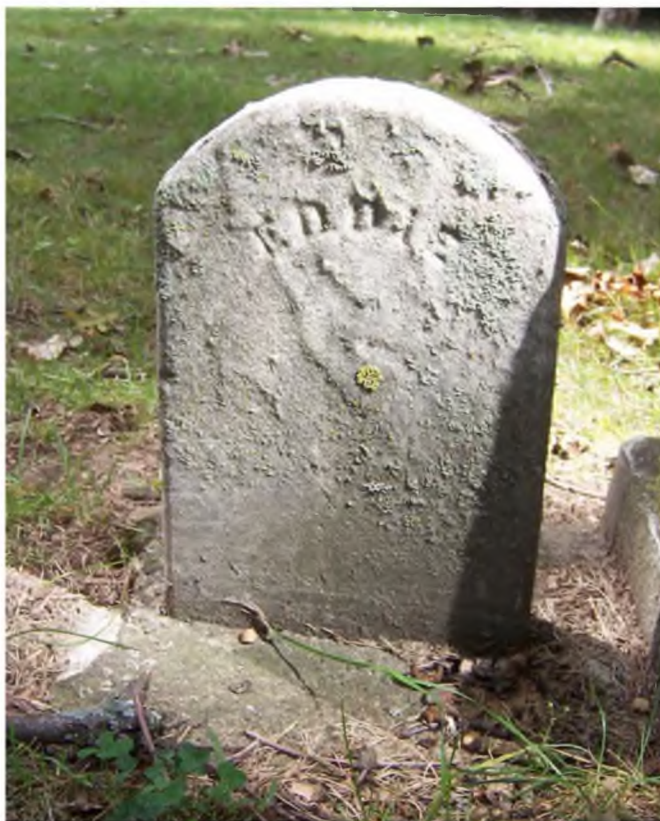
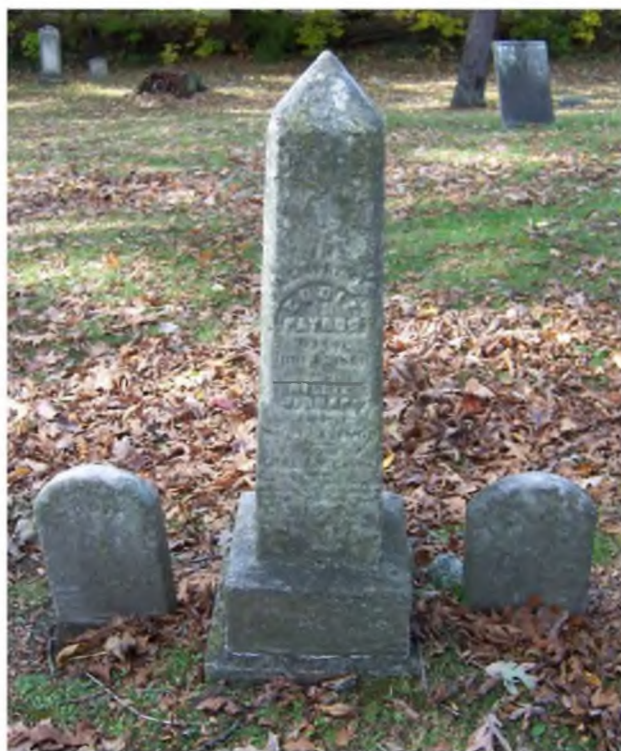
East:
EDDIE

Height: 13"

Width: 9"

Thickness: 2"

| <input type="checkbox"/> Leaning in Ground | <input checked="" type="checkbox"/> Repaired | <input checked="" type="checkbox"/> Biological (moss / lichen covered) |
| <input checked="" type="checkbox"/> Mower Scars | <input type="checkbox"/> Portions Missing (list): | |

“die in socket”-style footstone

Previous Repairs: There is a large amount of cement holding this marker in place.

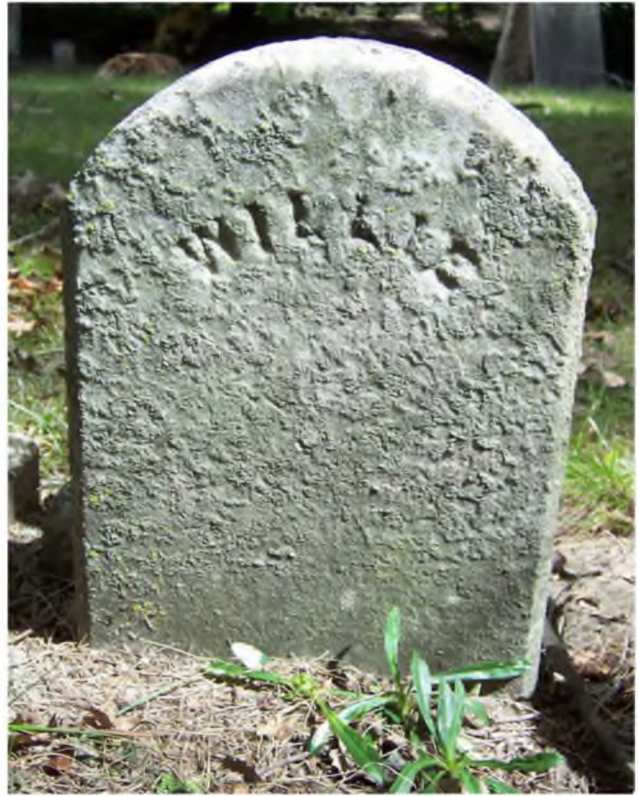
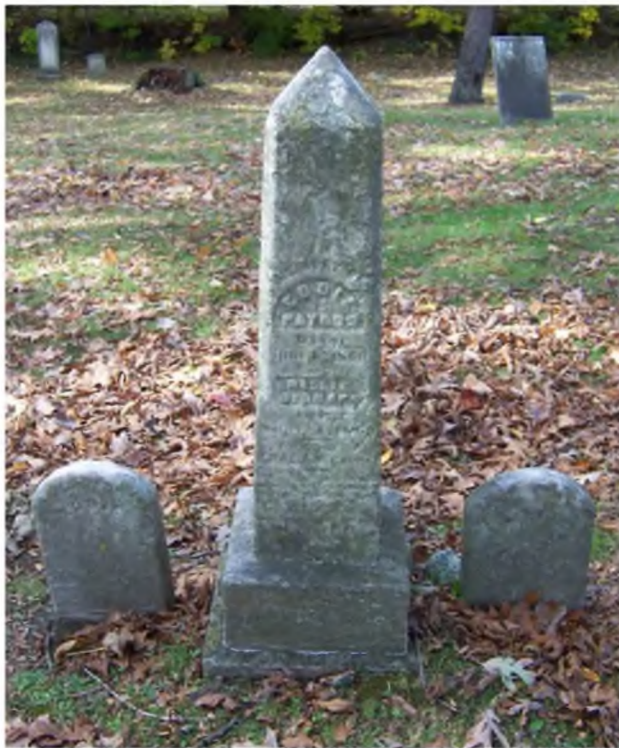
East:
WILLIE

Height: 12"
 Width: 9"
 Thickness: 2"

| <input checked="" type="checkbox"/> Weathered | <input type="checkbox"/> Cracked | <input type="checkbox"/> Broken—# of pieces: |
| <input type="checkbox"/> Leaning in Ground | <input checked="" type="checkbox"/> Repaired | <input checked="" type="checkbox"/> Biological (moss / lichen covered) |

“die in socket”-style footstone

Previous Repairs: There is a large amount of cement holding this marker in place.
