Marker # 341

Surname(s): Blackwood

Inscription Transcription and Photo(s):

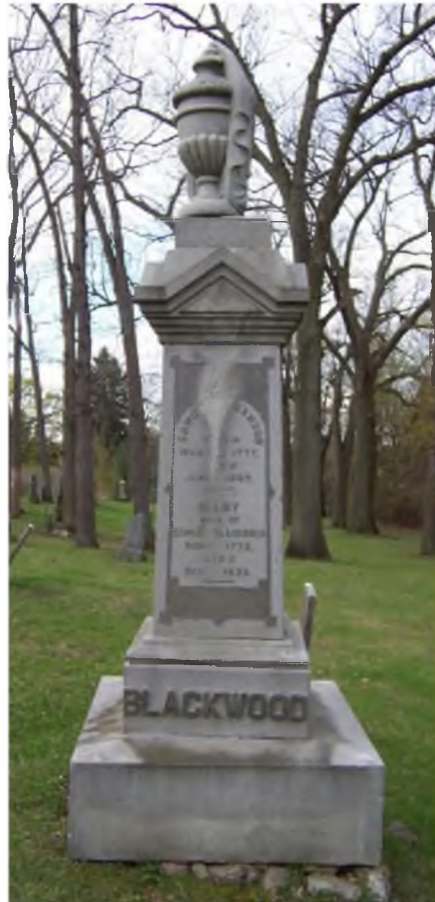
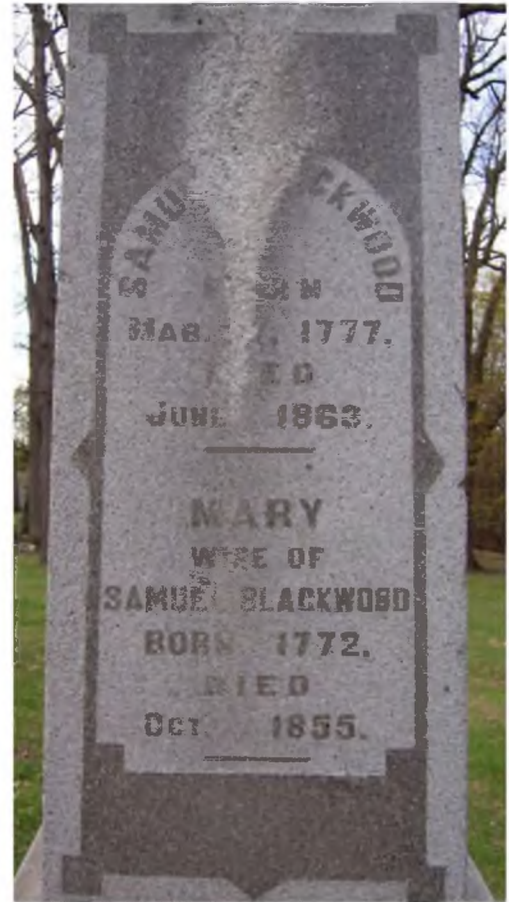
Samu[el Bla]ckwood  
[Bor]n  
Mar. [17], 1777.  
[Di]ed  
June 1863.

Mary  
Wife of  
Samuel Blackwood  
Born 1772.  
Died  
Oct. 1855.

**Gravestone Design Features/Motifs:** draped urn on top of monument

- Sound
- Weathered
- Vandalized
- Leaning in Ground
- Missing (base only)
- Mower Scars
- Other (describe): Section 1 (the urn) is shifted on Section 2. Section 4 is shifted on Section 5. Section 5 is shifted on Section 6. The stone is exfoliating due to heavy mica content.
- Stained / Discolored
- Cracked
- Unattached to Base
- Repaired
- Loose (not in ground, but marks grave)
- Portions Missing (list): Corners are missing from Sections 4 and 5
- Buried
- Broken—# of pieces:
- Overgrown (grass / groundcover)
- Biological (moss / lichen covered)
- Displaced (not marking grave)
