Marker # 358

Surname(s): Lyke

Emely,  
Wife of  
Alexander Lyke  
Died  
[May] 29, 1861.

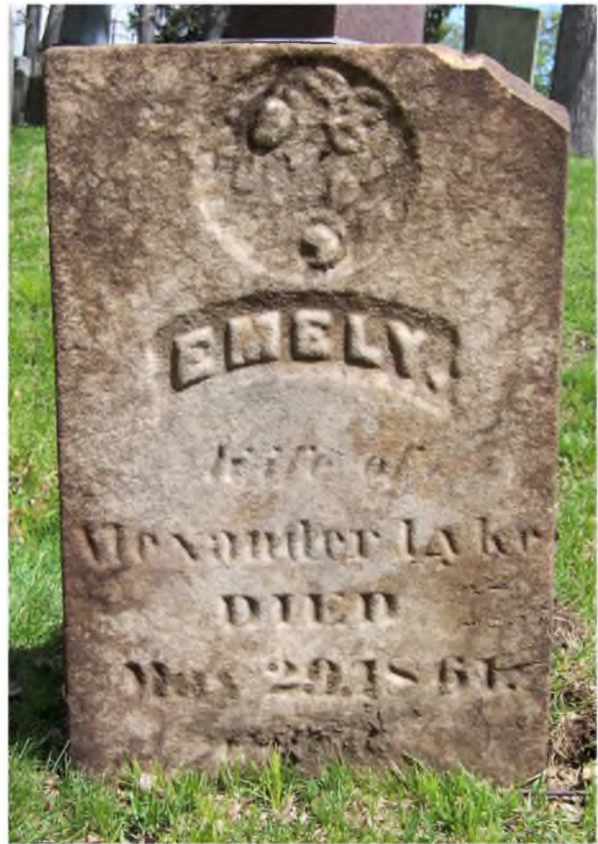
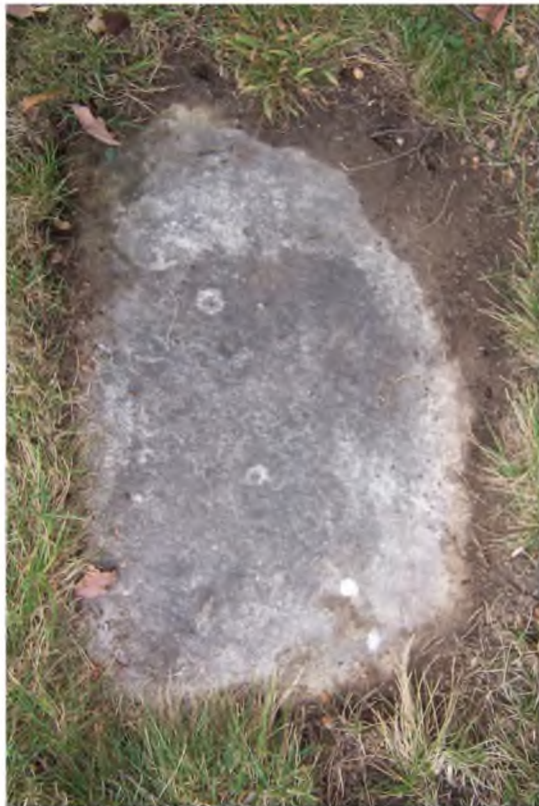
marker is currently face-down on the ground.

- Sound
- Weathered
- Vandalized
- Leaning in Ground
- Missing (base only)
- Mower Scars
- Other (describe):
- Stained / Discolored
- Cracked
- Unattached to Base
- Repaired
- Loose (not in ground, but marks grave)
- Portions Missing (list): This marker is broken across the bottom and the lower portion is missing. The upper-right corner is also missing.
- Buried
- Broken—# of pieces: 1 found
- Overgrown (grass / groundcover)
- Biological (moss / lichen covered)
- Displaced (not marking grave)

**Previous Repairs:** There is cement residue near the bottom of this broken marker, partially obscuring the death date. The cement indicates that this marker was repaired at one point, but the repair has since failed.

**Remarks / Comments:** This displaced marker is currently located about 3.5 feet south and just east of Marker 357.
