Marker # 38

Surname(s): Palmer

Marker # 38A

Marker # 38B

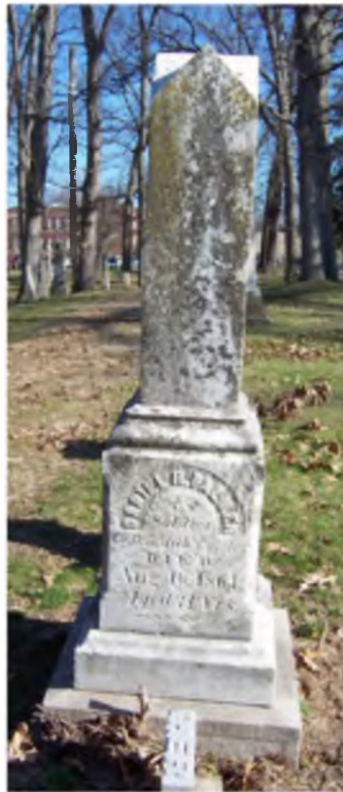
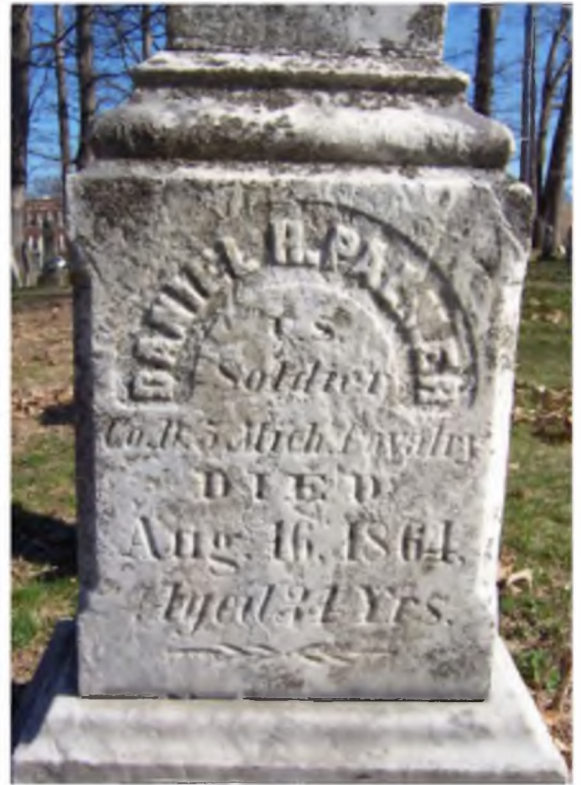
South:

Daniel H. Palmer
U.S.
Soldier
Co. D 5[] Mich. Cavalry
Died
Aug. 16, 1864,
Aged 34 Yrs.

1: 36.5”h x 10.5”w x 10.5”d
 2: 25.5”h x 17”w x 17”d
 3: 6.5”h x 22.25”w x 22”d
 4: 5.5”h x 28”w x 28.5”d
 Total Height: 74”

pedestal tomb - vaulted roof

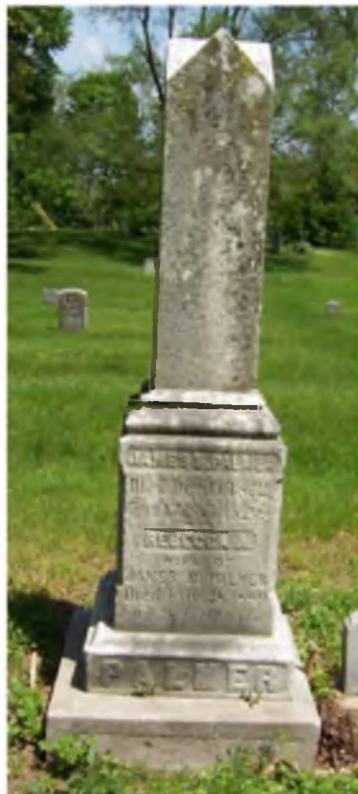
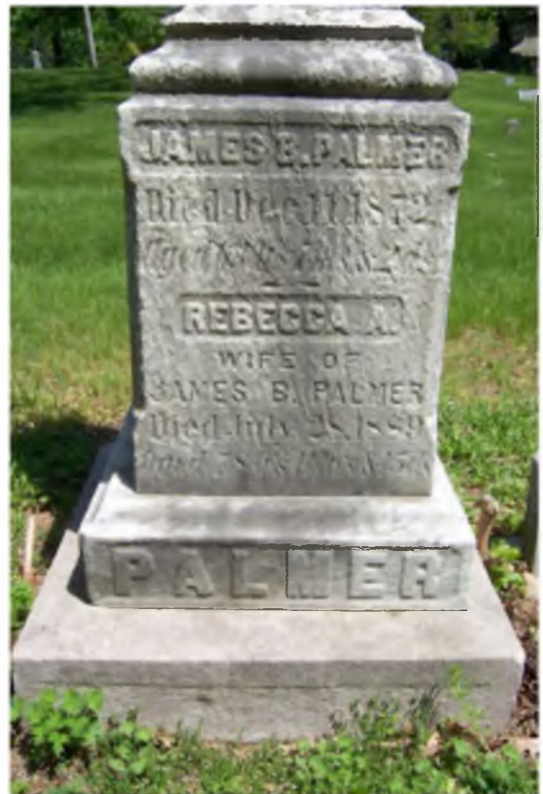
West:

James B. Palmer
Died Dec. 11, 1872
Aged [63 Ys, 7 Ms & 2 ds.]

Rebecca A.
Wife of
James B. Palmer
Died July 28, 1889
Aged 78 Ys, 11 Ms & 15 ds.

PALMER

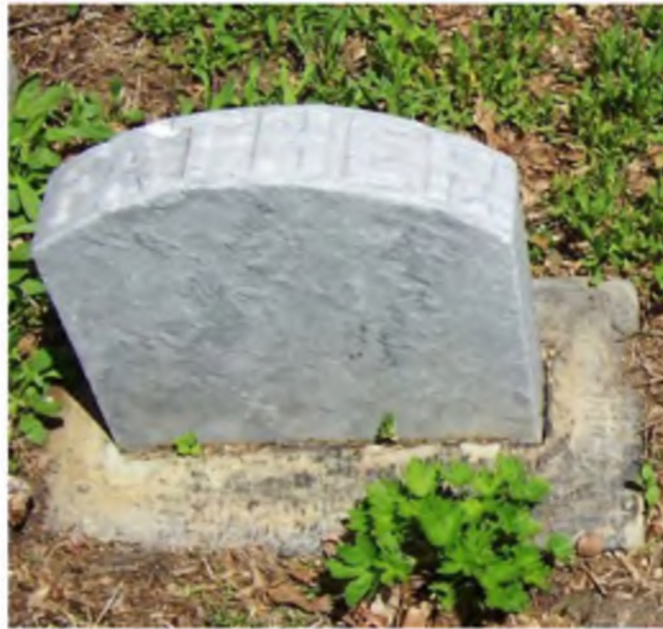
Oriented West:

FATHER

Height: 10.75"
 Width: 12"
 Thickness: 2.75"
 (sandstone base not measured)

“die in socket”-style footstone

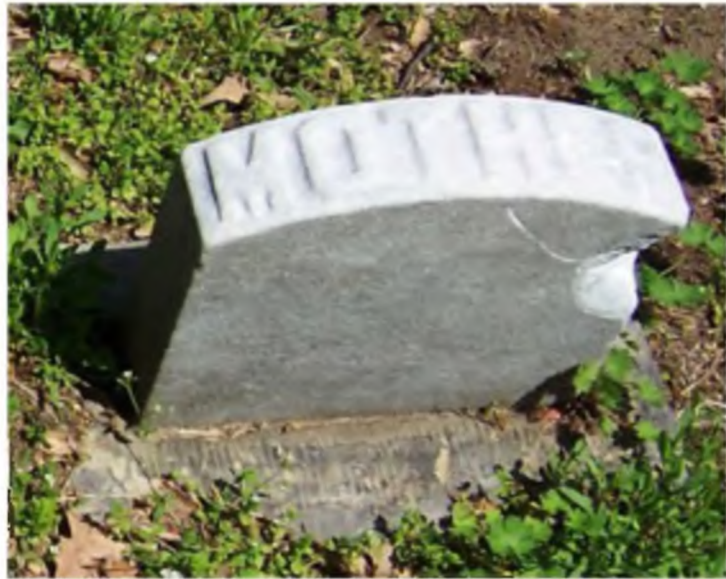
Oriented West:

MOTHER

Height: 9.5"
 Width: 12"
 Thickness: 3"
 (sandstone base not measured)

| <input type="checkbox"/> Vandalized | <input checked="" type="checkbox"/> Unattached to Base | <input type="checkbox"/> Overgrown (grass / groundcover) |
| <input checked="" type="checkbox"/> Other (describe): A small chunk of the stone is missing from the right-hand side; possibly damage from a lawn mower. | | |

“die in socket”-style footstone
