Inscription Transcription and Photo(s):

Charles Lawson
Died
[Oct.] 30, 1879
Aged
[27 Years.]

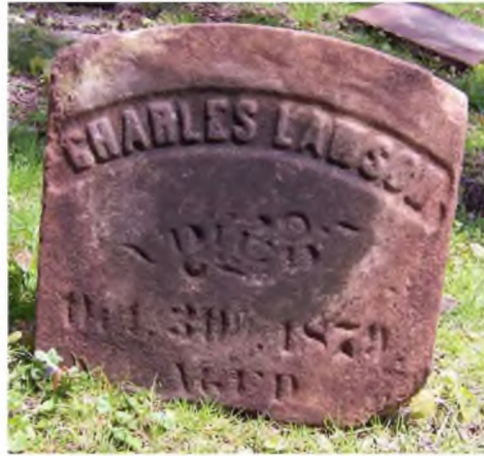
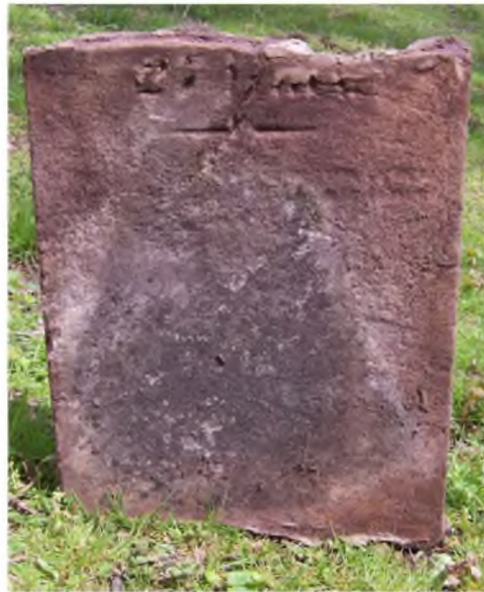
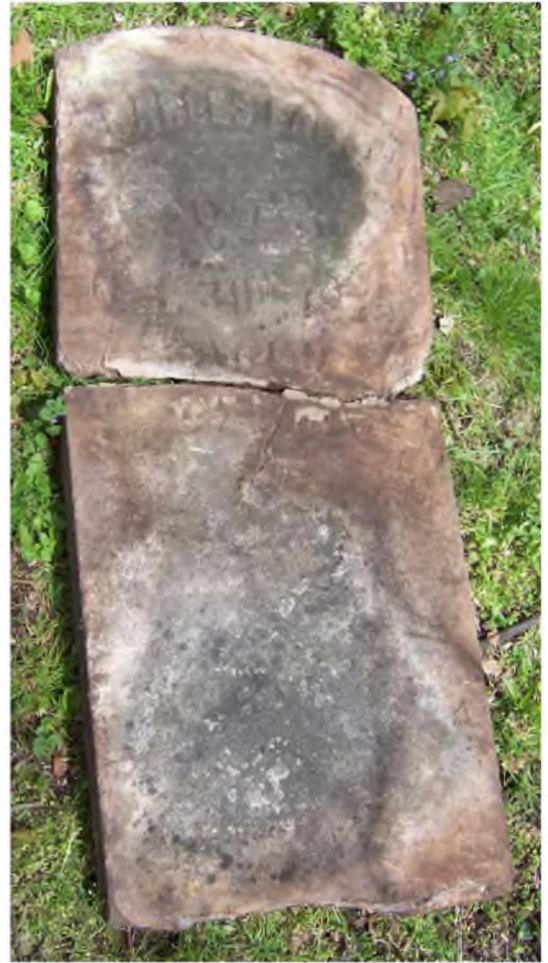
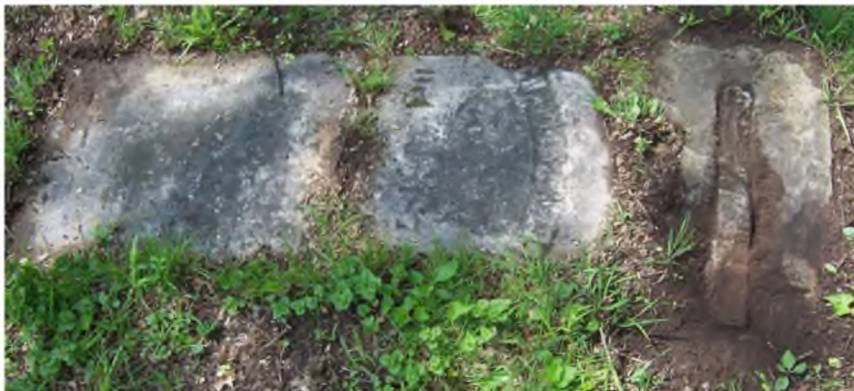
Arrangement of pieces and socket (2013)

- Sound
- Weathered
- Vandalized
- Leaning in Ground
- Missing (base only)
- Mower Scars
- Other (describe): This marker is broken across the bottom, with the base of the stone still in its socket.
- Stained / Discolored
- Cracked
- Unattached to Base
- Repaired
- Loose (not in ground, but marks grave)
- Portions Missing (list):
- Buried
- Broken—# of pieces: 3 + piece in socket
- Overgrown (grass / groundcover)
- Biological (moss / lichen covered)
- Displaced (not marking grave)

Previous Repairs: The two main pieces were caulked together at some point, but have since come apart again.

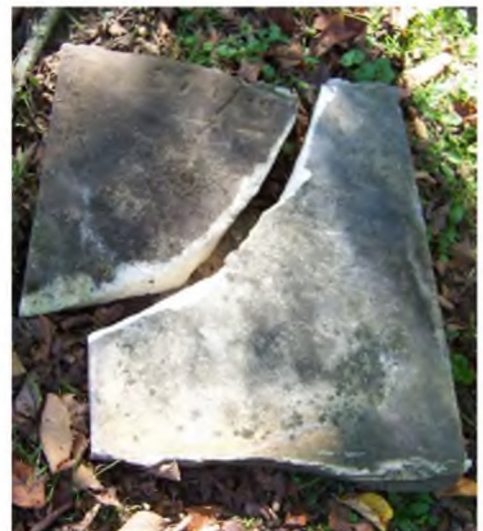
Stone broken (2014)

Remarks / Comments: The lower section was found broken and out of the ground in September 2014.
