Marker # 417

Surname(s): T.

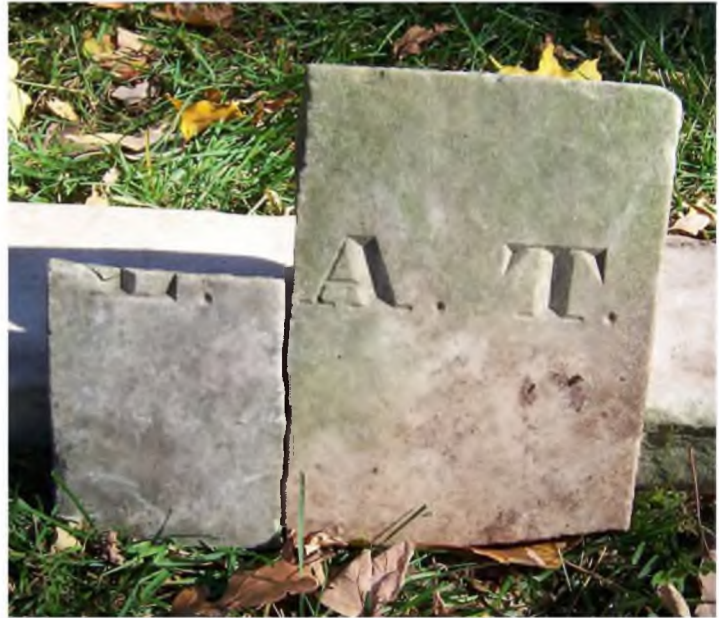
[]. A. T.

Height: 8" (as is)
 Width: 9.5"
 Thickness: 1.25"

- Sound
- Weathered
- Vandalized
- Leaning in Ground
- Missing (base only)
- Mower Scars
- Other (describe): The smaller piece in the photo is broken laminarly, thus creating two pieces.
- Stained / Discolored
- Cracked
- Unattached to Base
- Repaired
- Loose (not in ground, but marks grave)
- Portions Missing (list): The upper-left corner and the bottom half of this marker were not found.
- Buried
- Broken—# of pieces: 3 found
- Overgrown (grass / groundcover)
- Biological (moss / lichen covered)
- Displaced (not marking grave)

headstone-style footstone

Remarks / Comments: This footstone was found in the southwest corner of the cemetery, along with various other gravestone and socket pieces. It was moved into the locked cemetery crypt for safekeeping in Oct 2014.
