Marker # 48

Surname(s): Rowland

Inscription Transcription and Photo(s):

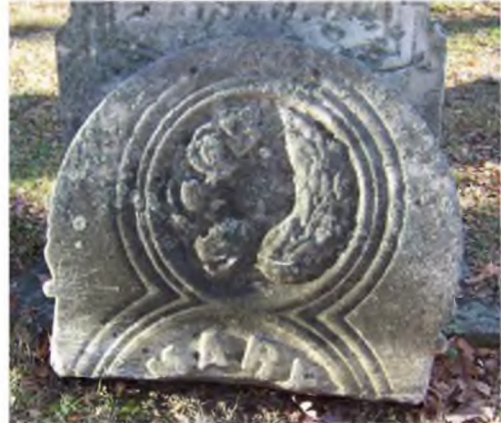
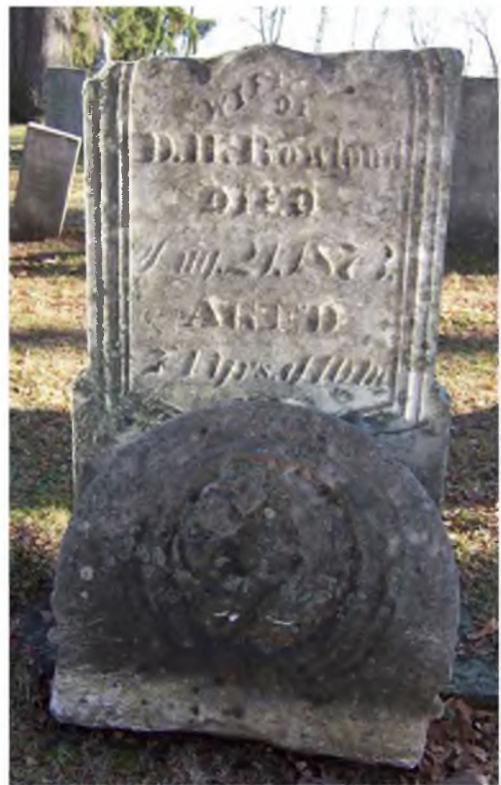
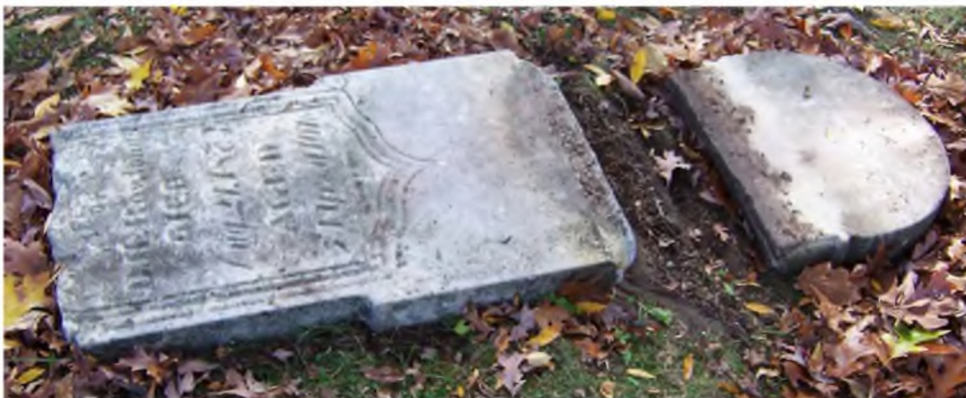
West:
Mary
Wife of
D. H. Rowland
Died
[Aug]. 21, 187[3].
Aged
[74] Yrs & 10 M.

October 2014:
This marker has now fallen over.

- Sound
- Weathered
- Vandalized
- Leaning in Ground
- Missing (base only)
- Mower Scars
- Other (describe): The sandstone socket is disintegrating. A crack is forming across the text.
- Stained / Discolored
- Cracked
- Unattached to Base
- Repaired
- Loose (not in ground, but marks grave)
- Portions Missing (list):
- Buried
- Broken—# of pieces: 2
- Overgrown (grass / groundcover)
- Biological (moss / lichen covered)
- Displaced (not marking grave)

Remarks / Comments: The top portion of the stone (including the floral wreath and the word "Mary") is broken off and leaning on the bottom part of the stone.
 Update October 2014: The bottom part of the stone has fallen over.

Previous Repairs: The bottom part of the stone was cemented into the socket at one time.
